Light on cargo fires

Reports have recently reached the Club of a substantial claim involving a cargo fire caused by the improper operation of cargo lights.

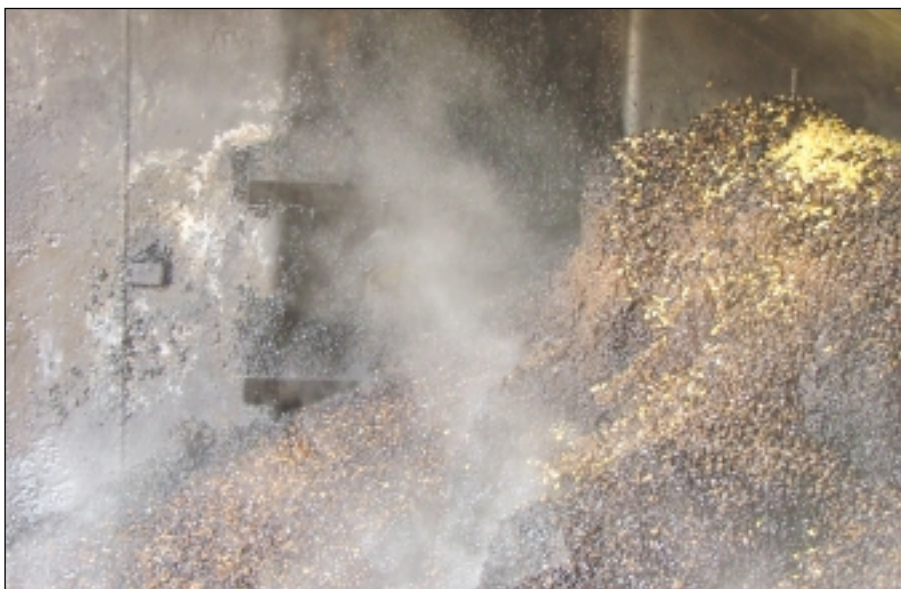
The case concerned four 500-watt quartz halogen cargo lights, positioned high up under the weather deck of a vessel loading maize and wheat bran pellets. The lights were operated by four separate switches mounted on a single control box in the mast house between holds 2 and 3. Each hold was lit by two lights. A number, written in faded red ink, poorly identified the light that each switch operated. It was easy to assume the switches operated the lights in only one hold.

surface of the stow. The vessel then shifted to another terminal and started loading the wheat bran pellets into hold 2 during the hours of darkness. When the hold 2 lights were turned on, all four switches - including those operating the already full hold 3 - were activated. It was only much later, after loading, that smoke was seen coming from hold 2, and smouldering fires were discovered directly under both lights in each of the holds.

Investigations revealed that even much lower-wattage lamps than the ones involved in this case may give rise to fires if in direct contact with grain cargoes. So Members are urged to ensure that crews - and especially those new on board or still being familiarised with the operation of the vessel - are made fully aware

of safety procedures concerning the operation of lights. Standard measures will include the removal of fuses or the pulling of circuit breakers immediately before grain or other potentially combustible bulk cargoes are loaded. If additional lighting is required, it is standard practice to employ portable cluster lamps hung over the side of the hatch coamings.

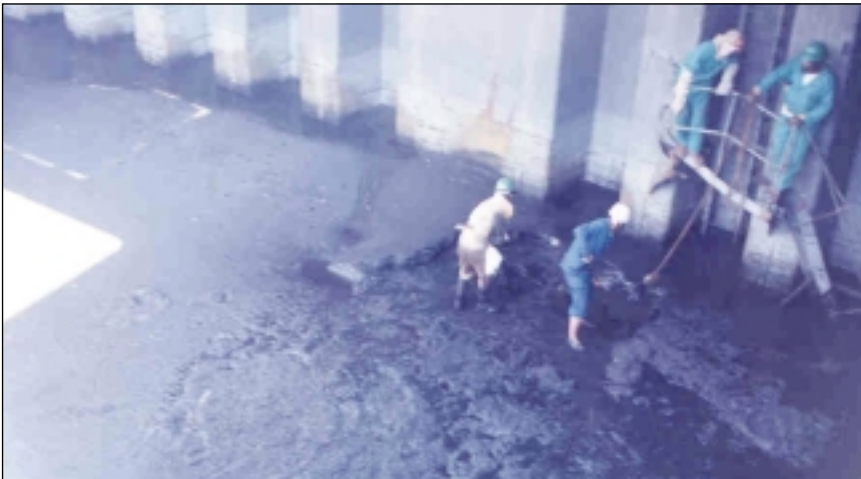
The Club has very recently received reports of a number of casualties involving vessels laden with Chinese fluorspar cargo, carried from Hong Kong.

The vessels in question are said to have developed severe lists. In one instance, the result was the reported loss of the vessel off Sri Lanka. And in another case it was necessary for the crew to abandon ship.

The information so far available indicates some connection between the casualties and the cargo carried - in particular, its moisture content and flow properties.

particles can undergo liquefaction during ocean transport, if shipped above the transportable moisture limit. Accordingly, to prevent hazardous liquefaction occurring, the IMO BC Code (which includes a non-exhaustive list of other materials capable of attaining a flow state) requires the testing of cargo flow properties and certification by shippers, prior to loading.

However, in the recent cases, it appears that the only information provided by the shippers concerned the moisture content of the cargo and contained no data regarding its flow properties. In the circumstances, members are reminded to be aware of the potential risks involved with the carriage of such cargoes and of the related provisions of the IMO BC Code.

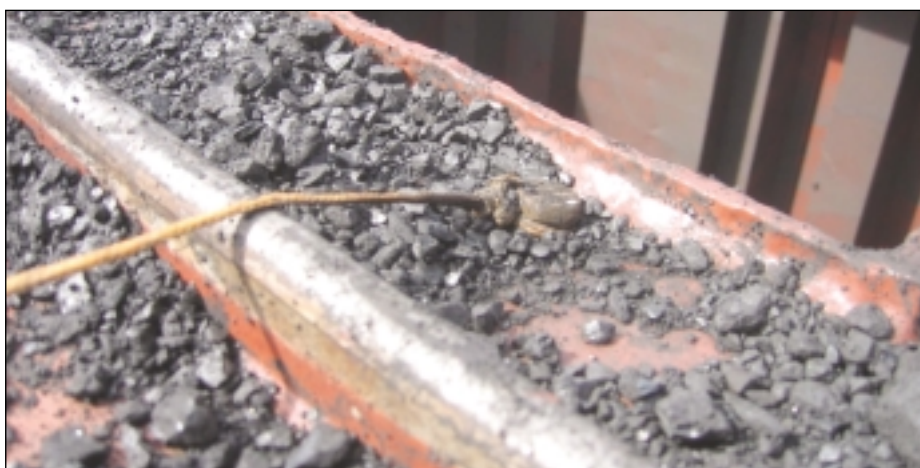
One of the problems typically encountered during the loading and unloading of some bulk materials, and particularly coal, is blockage of the vessel's hatch coaming drains by such cargo. And one way by which an attempt was made to address the difficulty was to temporarily plug the coaming drain holes during loading and discharge, to prevent that sort of clogging.

However, it is of course imperative to ensure that, upon completion of cargo work, the hatch covers are not closed with the plugs still in place. And, as can be seen in the photograph above, attaching a coloured lanyard to the bungs can serve as a useful safeguard against such an oversight.

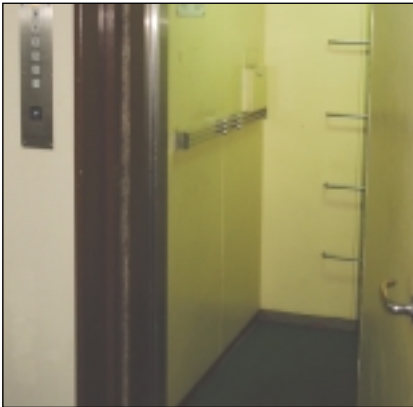
Regular safety-related checks must be maintained

elevator shaft, as a result of which he suffered serious injuries. The accident occurred when the engineer called the elevator from the main deck. When the elevator door opened, the engineer stepped inside. Unfortunately, the elevator itself was on the lower engine-room deck, and consequently the engineer fell down the lift shaft from a height of two storeys.

Members are reminded of the importance of proper onboard safety and maintenance procedures. And so far as elevators, specifically, are concerned, great care should be taken over responsibility for and retention of any override keys, while all safety-related interlocks should be fully operational. There is no substitute for routine testing and regular maintenance.
