## Take care when mooring

**T**he Club has recently seen a tragic case emphasising the very close care and attention required - on board and ashore - during the mooring and unmooring of ships.

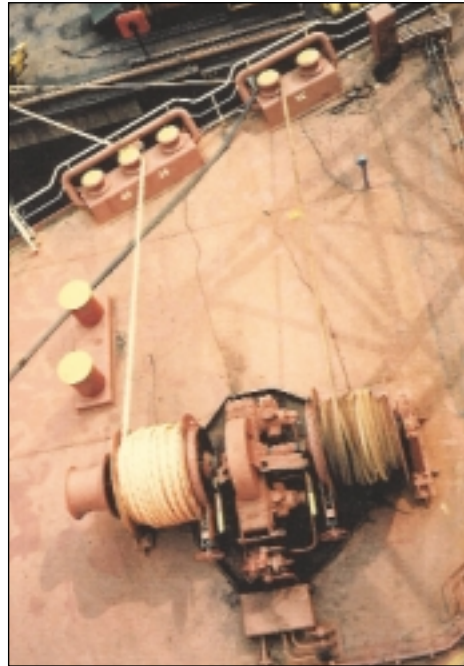
The vessel concerned was preparing to leave a river berth and all of the mooring lines except one had been let go. As the current caught the ship the load on the last line, which was held fast on a winch brake, increased significantly. The officer in charge of the mooring station was uncertain whether he had missed an order to let go the last line. But as he sought clarification the

line parted suddenly and struck a mooring man waiting on the quayside.

The subsequent death of the mooring man serves as a salutary reminder of the need for particular care in such operations. And important general principles are contained in the UK Maritime & Coast Guard Agency's Code of Safe Working Practice for Merchant Seamen, which makes the point that:

*...Immediate action should be taken to reduce the load should any part of the system appear to be under excessive strain...*

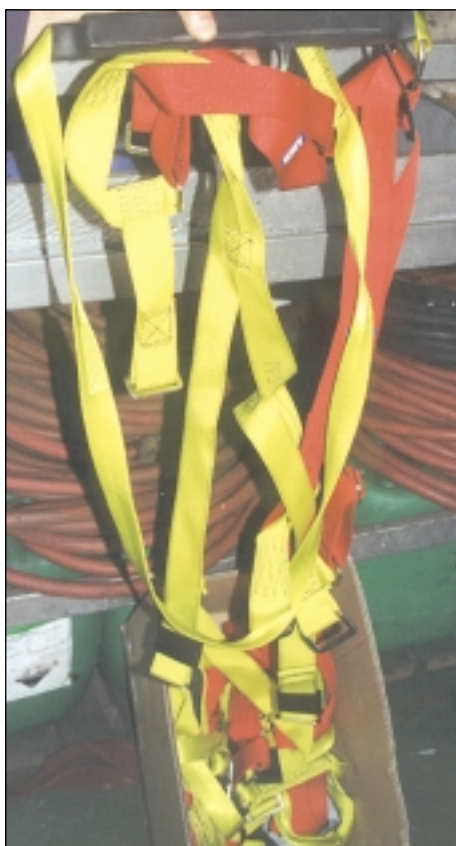
**A** recent claim serves as a further reminder of the potential risks involved while working aloft - and the need for personnel involved in such activities to take careful measures to prevent falls.

The case concerned injuries sustained by a crewmember, who fell from a stage while painting the ship's funnel. Although the crewmember was wearing a suitable harness, it seems that he had unclipped this from the lifeline while painting. As a result, the harness provided no protection whatsoever when the crewmember fell. The case highlights the importance of proper safety practices and procedures - including supervision - while crew are working aloft.

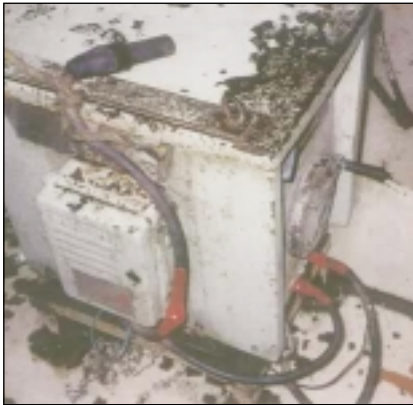
**A** recent accident resulting in the death of a shipyard welder, while working onboard a Member's ship, emphasises the importance of following proper safety procedures in performing such operations.

Investigations revealed that the welder was killed while using the yard's equipment and indicated - in

particular - the welding cable to be in poor condition and that several breaks in the insulation had been covered with electrical tape. The death occurred during welding and when the welder's arm touched a damaged section of the cable. The level of danger was most likely increased by very humid atmospheric conditions which had dampened the welder's clothes.

Although there was no liability on the Member's part in this case, it nevertheless highlights generally the need for extremely strict inspections of cable condition prior to use. And it also underlines the importance of attention to other safety issues, including the use of proper clothing and footwear.
