Problems with permits to work

IN THIS ISSUE

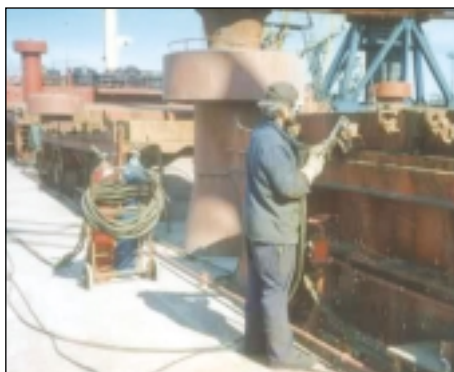
A recently reported accident is an example of the latter problem. In that case, a ship's welder was badly burned while conducting planned maintenance on the hatch cover operating system. The welder had replaced several lengths of hydraulic pipe in the system during the course of the voyage, using oxygen-acetylene equipment to cut corroded flange bolts in the process. Each time the cutting equipment was used, the responsible officer first conducted a risk assessment and issued a permit to work. This had included an instruction that the welder close an

isolation valve between the hydraulic pumps and the operating controls, to prevent the system being inadvertently pressurised. Apparently, the officer had been confident there was no significant risk of ignition to the hydraulic oil in the line.

In contrast to the position at the time of the accident, the welder's earlier work had been performed while the hatch covers were closed. However, on the day that his injuries were sustained, the hatch cover had been 'tented' to provide natural light to other crew members working in the hold. As a result, the load on the hydraulic system had pressurised the oil in the section of line to be replaced, before the welder followed the responsible officer's usual instruction to close the isolation valve.

And as the welder cut through a bolt in the flange, hydraulic oil escaped from the line under pressure, creating an oil mist which exploded on contact with the oxygen-acetylene flame. The welder suffered severe burns over forty per cent of his body. The subsequent inquiry indicates that the officer who signed the permit to work did not fully appreciate that hydraulic oil escaping under pressure from the line could form an explosive mist. Moreover, neither he nor the supervising officer appreciated that tenting the hatch covers would pressurise the system or that the closure of the isolation valve would provide no protection if the system was already pressurised.

This accident serves as a reminder that the risk assessment undertaken prior to the issuance of a permit to work should be carried out by suitably experienced personnel, using specialist advice if necessary.

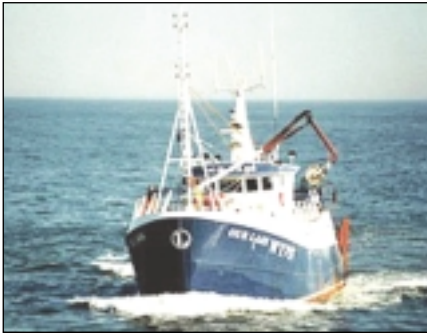
The Club has recently received news of a number of collisions between merchant ships and vessels engaged in fishing. A common feature of these casualties appears to be the passing of fishing craft at an unsafe distance. In one case, the skipper of a trawler died as a result of a collision when his vessel was struck by a large laden bulk carrier. The bulker's officer of the watch

(OOW) had detected, both visually and by radar, the presence of a group of fishing boats on his starboard bow at a distance of at least ten nautical miles. These boats were crossing ahead, but the OOW quickly established that there was a risk of collision with at least one of the group.

There was ample sea room to starboard to make a bold alteration of course, which would have left all of the fishing boats well clear to port. However, the OOW instead made only a small alteration of course to starboard which gave a closest point of approach to the nearest fishing vessel of only half a nautical mile. Of course, apart from the allowance to be made for the

distance between the radar scanner and the bow of the ship, that projected passing distance was dependent upon both vessels maintaining their course and speed. Unfortunately, the developing close quarters' situation was not monitored properly after an inadequate watch handover on the bulk carrier. Despite the relieving OOW's last-minute hard-a-starboard manoeuvre, the bulk carrier struck the fishing vessel, causing it to capsize and quickly sink.

The investigating authority emphasised the need for navigating officers in similar circumstances to make an early and substantial alteration of course to achieve a safe passing distance - and to monitor the effectiveness of the alteration until the other vessel is finally past and clear.

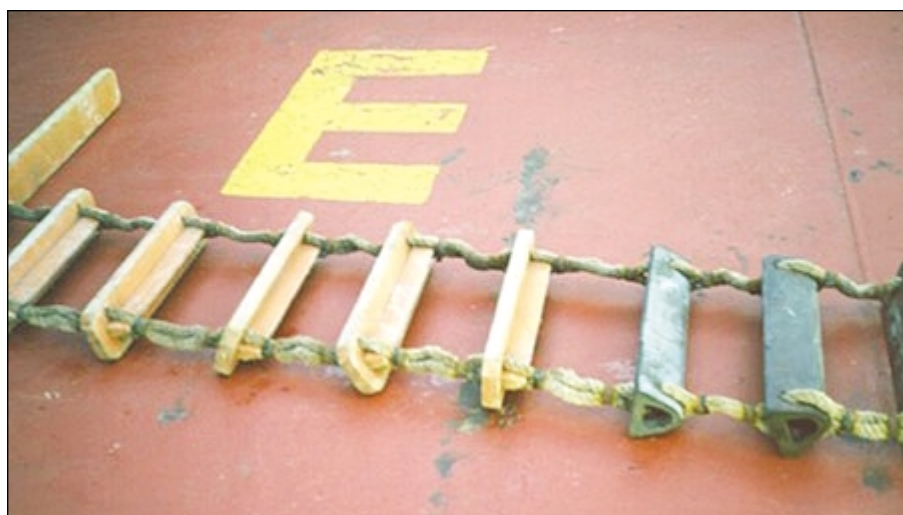
Dublin, the side ropes of a pilot ladder gave way, and the pilot fell back into the pilot cutter, together with a section of the ladder. Fortunately, the pilot on this occasion was not seriously injured, but a subsequent port state investigation found that both the port and starboard pilot ladders

were permanently rigged and open to damage from the weather, the action of the seas and the sun, in contravention of SOLAS Chapter V Regulation 23.

The failure was found to have been caused by a significant loss of strength in the ropes used in the ladder construction, caused by external abrasion. The position of the failures in each leg suggested that flex fatigue had also contributed to loss of strength.

The general appearance of the failed ladder suggested that it had been in service for a considerable period of time, and there was no evidence of regular inspection as required under SOLAS.

Members are reminded that it is essential to ensure that pilot ladders are inspected regularly, and properly stowed when not in use.
