## Following procedures for entering enclosed spaces

**S**topLoss has previously emphasised the critical importance of seafarers' adherence to proper safety procedures, prior to entering enclosed spaces.

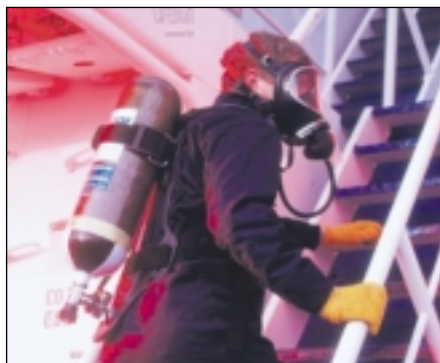
But the risk of oxygen depletion appears to have been misjudged, such that the oxygen content of the atmosphere was not tested prior to entry. The misjudgment became apparent when a crew member collapsed shortly after entering the chain locker. And since no such difficulty had been anticipated, his colleagues did not have breathing apparatus on standby.

The highest level of care is required during crew entry of enclosed spaces

The owner's investigation concluded that the gradual process of corrosion (oxidisation) of the anchor cable and the compartment structure had depleted the oxygen in the chain locker, which was not adequately ventilated prior to entry.

This near-miss serves as a reminder of the dangers of oxygen depletion in apparently innocuous enclosed spaces. And, while the successful rescue emphasises the importance of comprehensive safety and rescue training, the owners are considering whether personal gas detection monitors could further enhance safety procedures.

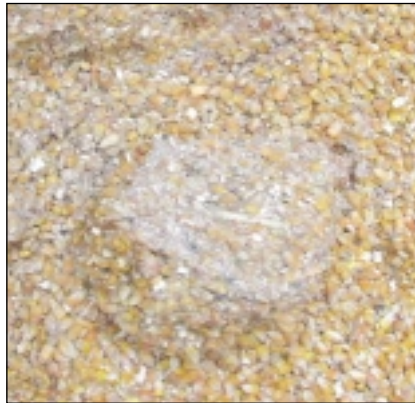
Inattention to the dangers of heat transfer from bunkers can leave cargo looking like this

And, particularly when the bunker tanks are relatively full, the heat can be transferred into the adjacent hold, resulting in discolouration and caking of the cargo. The heat transfer usually affects a relatively

shallow layer of cargo. But the position of the double bottom tanks is often such that damage extends across the length and breadth of multiple cargo holds. And the problem is often compounded by a subsequent difficulty in segregating sound from damaged and caked cargo during discharge, when the sound cargo remains free-flowing.

Investigations suggest that in more than one case the ship's engineers simply did not consider the potential impact on the cargo of their heating of the bunker tanks, and the deck officers did not monitor the bunker temperatures. So, the recent cases are reminders of the need for both engineers and deck officers to be aware of the risk of excessive bunker heating leading to cargo claims.

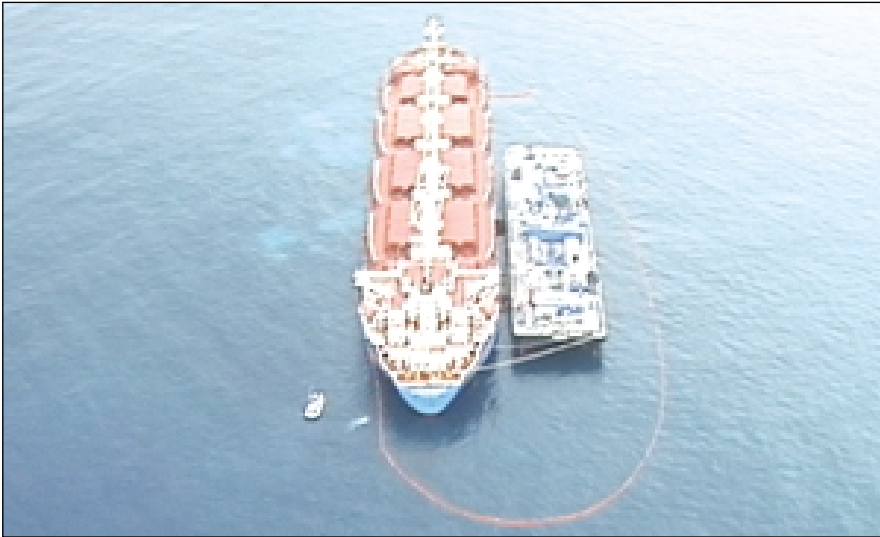
The use of parallel indexing should help to avoid casualties, including groundings (*above*) and related damage to coral reefs (*below right*)

The other casualty involved a feeder containership during an approach to an inner anchorage which required the vessel to pass relatively close to a charted coral reef. In this case, the ship had no formal passage plan and the master was unaware that a strong

current ran across the intended track. Although the end of the breakwater provided an obvious target for use in a simple parallel index, no use was made of it. And that omission had been compounded by fixing only by GPS and at insufficiently frequent intervals. As a result, the master only became aware that he was off track when the ship grounded heavily, causing damage to the reef.

Both these casualties illustrate the value of parallel indexing, in addition to the proper fixing of a ship's position at appropriate intervals.

In particular, parallel indexing provides 'real time' monitoring for cross track error between fixes, in that the radar target can be seen moving off the index line if the ship deviates from the track. And the use of the technique in these two cases should have given the bridge teams early warning that their ships were running into danger.
