## Vapour migration trail

## Crossed wires

## Don't tamper with safety

## Examining the twistlock issue

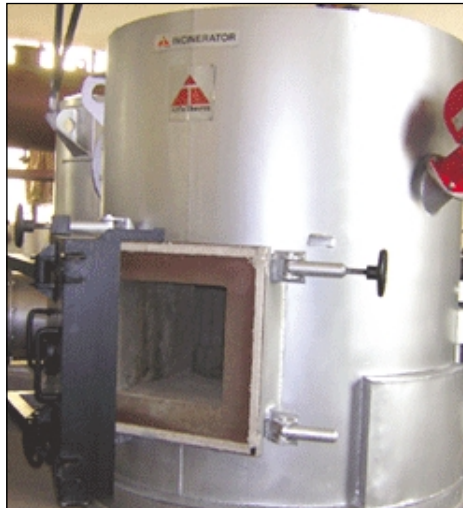
The case involved a wiper who suffered burns to his hand and forearm as he loaded waste material into a batch-fed incinerator. The design of the incinerator was such that the material was loaded directly into the combustion chamber.

An electrical interlock ordinarily prevents the door of the combustion chamber being opened until the chamber has cooled to a safe temperature, after the end of the incineration cycle. But in this case

the wiper tried the chamber door and, understandably, presumed that the incinerator was safe to use when the door opened. Unfortunately, he was injured when the waste material caught fire as soon as he fed it into the

combustion chamber. The initial presumption was that the interlock must have failed, but investigations very quickly confirmed that the interlock had been overridden by another crew member.

Apparently, the wiper's colleague was the regular operator of the incinerator and had decided to prevent the safety feature operating so as to be able to reload the incinerator without waiting for the chamber to cool.

Fortunately, the wiper was not badly hurt, but the potential for a very serious accident is obvious. The owner has now replaced the damaged interlock and reminded all ships in the fleet that safety procedures are in place for good reason.

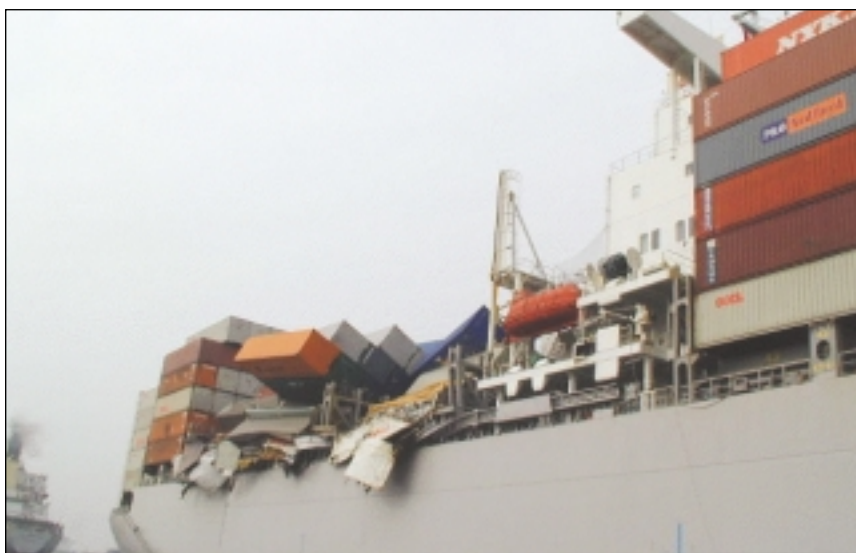
The design and size of large, modern containerships may be a factor in recent reported twistlock failures

The meeting was convened in the wake of continuing concern about losses of containers from large containerships. Research suggests that some such losses may be due to failures associated with the fully automatic twistlocks which are used to secure containers on board. Such concerns include the reported susceptibility of the twistlocks to sometimes disengage, which may be connected to the huge forces encountered when large containerships are operating in heavy seas.

- The dearth of industry knowledge about the real dynamic forces to which container lashing systems are subjected, and how these forces are affected by changing ship design and size.
- The failure of ISO standards to keep pace with the manufacture, testing and deployment of twistlock systems.
- The apparent correlation between the introduction of twistlock systems and the increased number of per-incident container losses.
- Handling, lashing and securing difficulties associated with the de-standardisation of container dimensions, together with the drive to reduce handling costs.

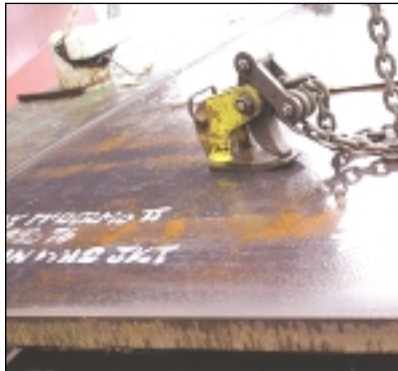
As the level of the overboard discharge was under the water line, while the pump was stopped but the valves remained open, the head of pressure caused water to run back through the pump. But the ship's staff had to investigate why the water then passed through the screw-down non- return valve in the engine room and through the non-return valve fitted just behind the bilge suction. In both cases, pieces of broken timber were found wedged in the valves, preventing them closing. The timber

was identified as broken pieces of dunnage used in the previous cargo. Further investigations suggested that the holds had not been swept thoroughly before they were washed prior to loading the steel plates. Moreover, the strainer lids

on the bilge wells had been removed during the hold washing, with the result that the small pieces of timber were first washed into the bilge well and then drawn into the bilge line. Fortunately, the ship's staff were able to freshwater-rinse the affected steel plates, and no cargo damage arose. However, the member has reminded its ships' staff of the need to take care to prevent cargo residues and other debris entering the bilge lines and of the need to test that the non- return valves are operational on completion of hold washing.

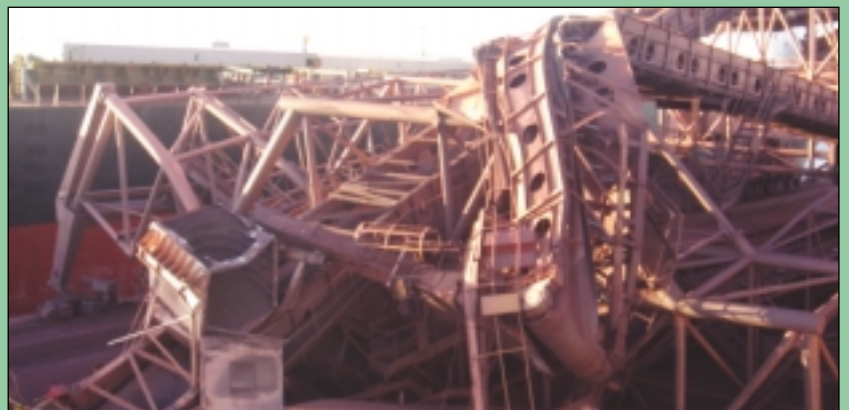
The photograph above shows the damage caused by the recent collapse of an iron ore loading arm at a berth while a member's vessel was alongside.
