## Loading manual and CSM reminder

### IN THIS ISSUE

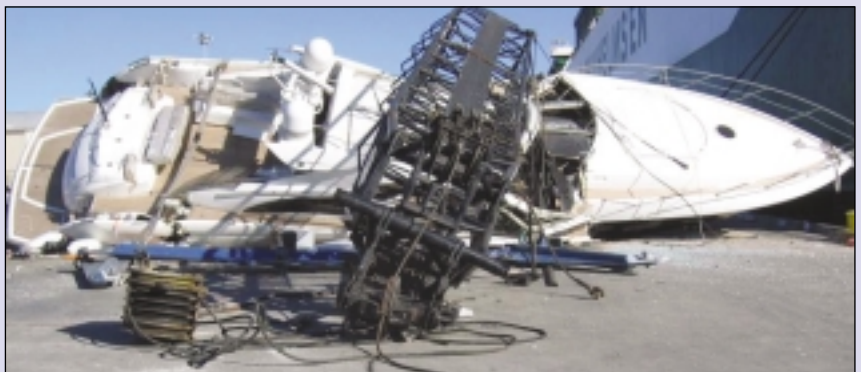
The above photograph shows the damage caused when a shore crane collapsed during discharge of a large yacht, which had been carried as deck cargo. The cause of the collapse remains under investigation.
