Passing the can test on nickel ore cargoes

StopLoss 42 (May, 2006) featured an article by Brookes Bell Jarret Kirman which highlighted the propensity to liquefy of nickel ore mined in Indonesia and the Philippines.

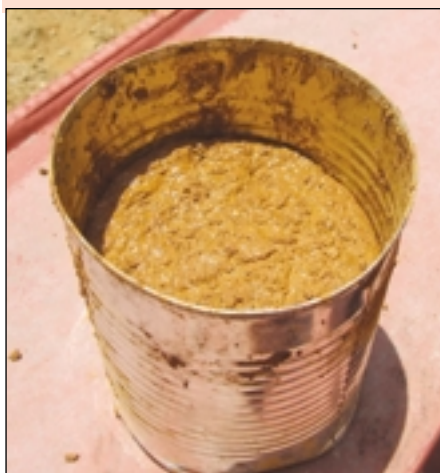
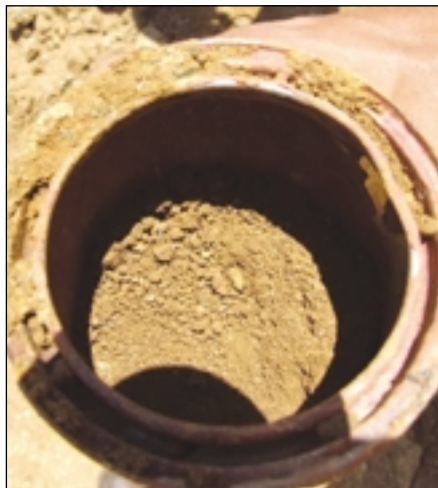
... into this, and the cargo may therefore be unfit for shipment

Striking on a hard surface a can containing a sample could turn this ...

Members considering carriage of nickel ore should be very cautious about relying on the shippers' documentation alone, and are reminded that guidance on how to conduct the can test is set out in Section 8 of the BC Code.

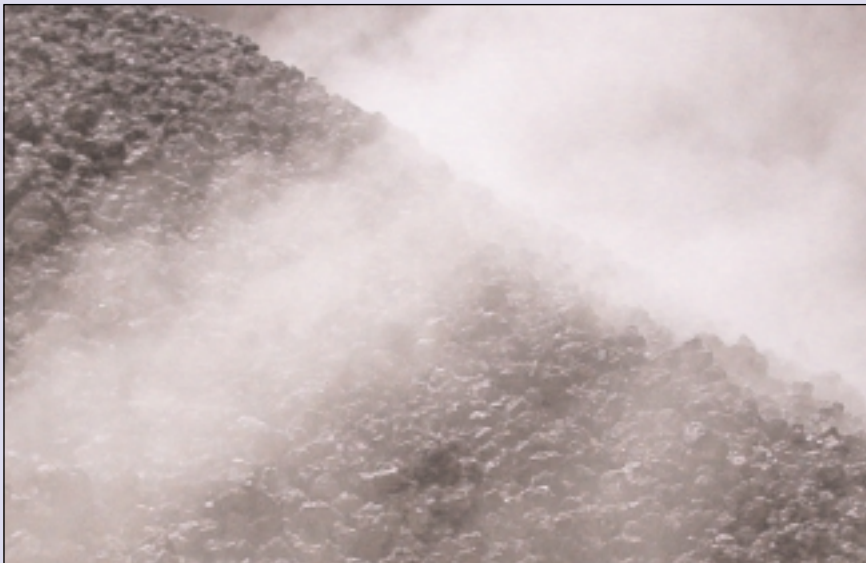
When a bulker arrived to load sintered ore, the master was understandably concerned about the temperature and condition of the cargo, which appeared to be giving off smoke (*see photo, left*). The local P&I surveyor quickly confirmed that the sintered ore was produced at an adjacent site and that the manufacturing process involves partially melting iron ore fines. The smoke is given off as the sintered ore cools on the quayside. As long as it is given sufficient time to cool, the carriage of sintered ore is generally unproblematic.
