IN THIS ISSUE

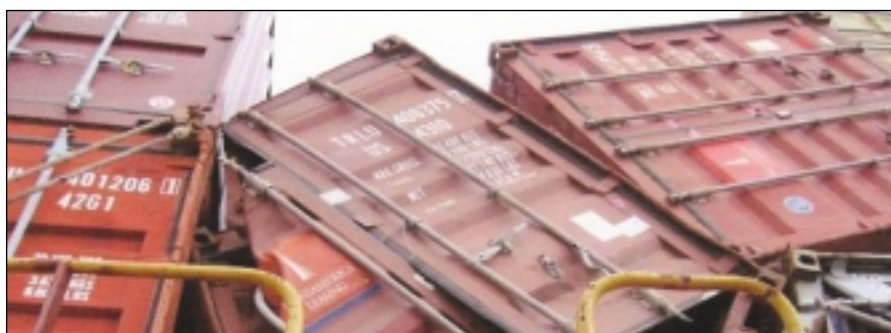
Premature opening of twistlocks

StopLoss 44 featured a report on industry concerns about losses of containers from large containerships and, especially, the possible role played in such cases by the failures associated with fully automatic twistlocks in heavy weather conditions. But the Club has also received reports on cases of collapsed container stacks which appear to have involved failures in the lashing of the cargo and a likelihood that the manual twistlocks were open at the time of the accident.

In one instance, the ship was within an hour of the end of a short sea passage. Bad weather had been experienced for much of the voyage, but a deck log book entry just prior to the incident recorded "pitching easily to moderate sea and swell on starboard bow. Spray forward." But the ship began to roll as soon as it turned for the pilot station and, very shortly thereafter, an outboard stack of containers toppled, with the majority of the boxes being lost overboard. It was common ground that none of the containers appeared to have collapsed under an excessive stack weight, and that the boxes did not appear to have been locked together as they went over the side.

The receivers initially alleged that the loss resulted from the crew removing the lashing bars and opening the manual twistlocks, before being caught out by the unexpected change in the ship's motion. But, on being reminded that the lost stack had been from the foremost bay on the outboard starboard side, the receivers did accept that, if the crew had decided to begin unlashings, they were very unlikely to have started on the weather side. The owners were still faced with a sizeable exposure to the claims as the most plausible explanation was that the stack had not been lashed properly by the stevedores at the load port, and that the ship's staff had failed to check the lashings at the time or on passage.

In a second case, a collapse of stow inboard during heavy weather experienced on the approach to a discharge port caused damage to 22 containers, most of which contained high-value goods such as televisions. A subsequent survey of the containers established that the twistlocks were open, which may have been the result of the crew having prematurely opened the securing devices.

While the pressure on operators in the container trades to achieve quick turnaround times is well-known, these cases underline the need for vigilant checking of container securing arrangements prior to departure, and emphasise the importance of ensuring that the containers remain lashed until the ship is safely alongside at the next port.
