## Indian ore liquefaction problems

### PUBLISHED

on behalf of The London Steam -Ship Owners' Mutual Insurance Association by A. Bilbrough & Co. Ltd.,  
50 Leaman Street, London E1 8HQ, UK.  
Tel: +44 (0) 20 7772 8000  
Fax: +44 (0) 20 7772 8200  
E-mail: [stoploss@a-bilbrough.com](mailto:stoploss@a-bilbrough.com)  
[www.lssso.com](http://www.lssso.com)

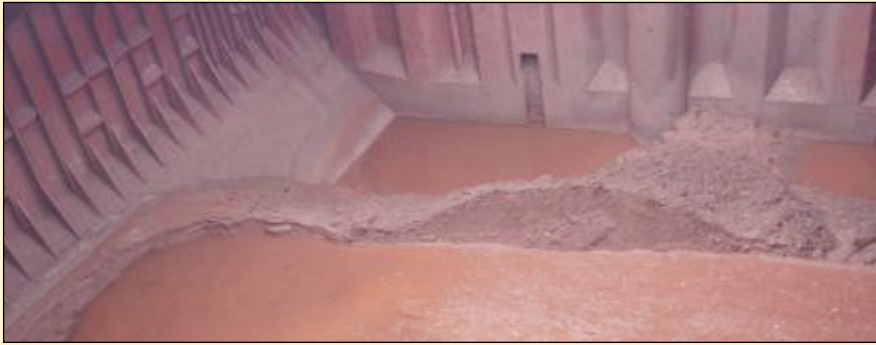
Free water is seen lying on top of liquefied ore fines

**I**n recent months, several ships have suffered serious stability problems as a result of liquefaction of iron ore fines loaded wet at various Indian ports, including Haldia, Visakhapatnam and Mangalore. At least three of the affected bulkers developed a dangerous list on passage, and two of the ships were beached as a result.

On the basis of recent experience, iron ore fines can fall into the category of a cargo which may liquefy. The 2004 edition of the Code of Safe Practice for Solid Bulk Cargoes (the BC Code) defines cargoes which may liquefy as "cargoes which contain at least some fine particles and some moisture,

The BC Code requires shippers of such cargoes to provide to the master, before loading begins, "a certificate on the moisture content and its transportable moisture limit". The cargo must not be carried if the moisture content exceeds the transportable moisture limit. Yet investigations show that, even with knowledge of the recent casualties, many shippers are reluctant or unable

Members considering loading iron ore fines from any Indian port should insist upon the production of the appropriate certificate before loading begins, and should also treat with caution any certificate provided by shippers. Where there is reasonable doubt as to the accuracy of certificates, members must be prepared to refuse to load the cargo pending further investigation into its actual condition. Readers are reminded that news on this and other loss prevention issues is available from the Club's website, from where registration to electronic News alerts is also available.

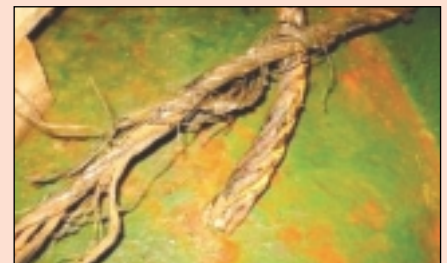
The Ship Inspection programme is an integral part of the Club's loss prevention activities. Recent inspection reports have highlighted a number of issues concerning the condition of steel wire ropes, whether used as mooring lines or cargo wires. The most common problem is corrosion, but wires suffering from fatigue and crushing damage have also been removed from service following inspections. Members

are reminded of the need - where appropriate - to replace steel wire ropes, particularly when the gear may have been mishandled or misused by linesmen or stevedores.

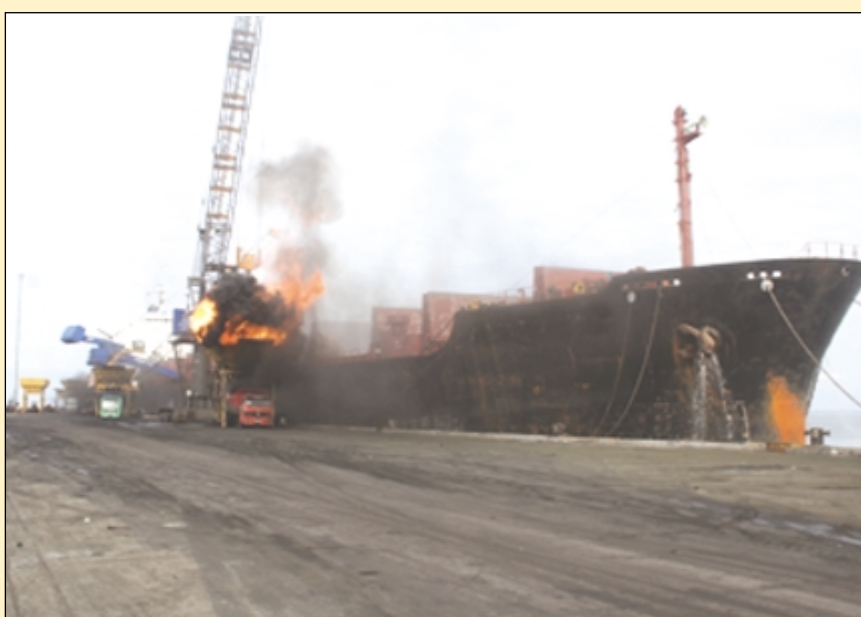
The photograph above was taken during discharge of a cargo of coal that had self-heated on passage.

The risks associated with such cargoes are not limited to damage to the ship and cargo. The investigation into a recent fatal accident in a ship's hold confirmed

that the crew member involved had been overcome by carbon monoxide, which is given off by the coal as it heats. Personnel should not be allowed to enter the holds unless they are wearing appropriate breathing apparatus and access is critical to the safety of life and/or the ship.

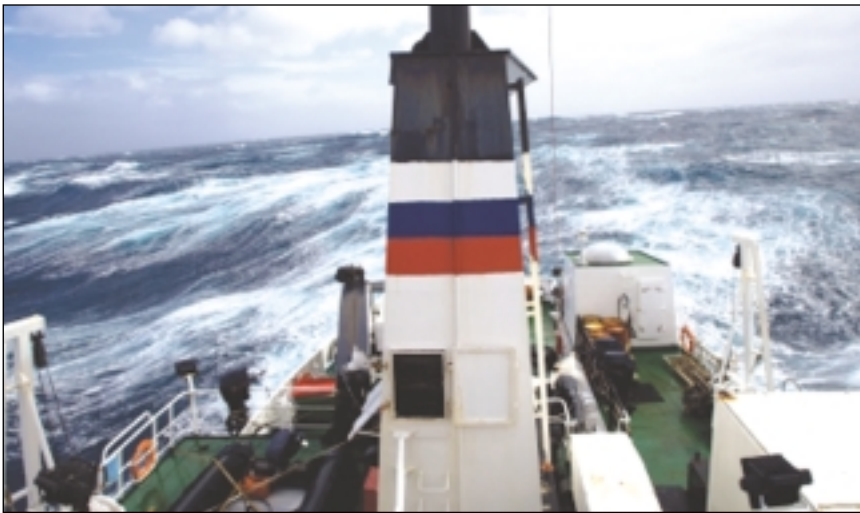
Heavy weather can be a significant causative factor in personal injury cases

**R**ecent personal injury cases handled by the Club have included accidents in which the ship's motion in heavy weather has been a causative factor.
