## Cocoa beans in a sweat

### IN THIS ISSUE

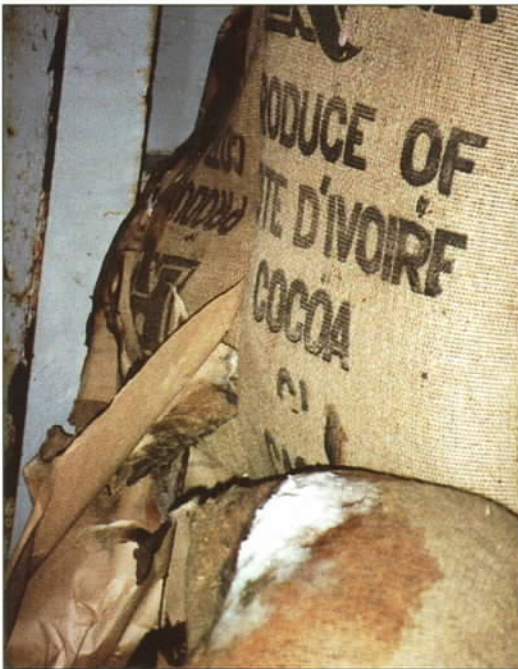
claimed that 9,500 bags were damaged. Investigation by the Club's surveyor revealed that the main source of damage was wetness caused by ship's sweat forming under the vessel's hatchcovers and thereafter dropping back onto the cargo.

Wetting and mould growth in the wings of Nos 2, 3 and 4 holds had been caused by poor stowage, which prevented effective ventilation, and as a result of incorrect ventilation procedures employed by the chief officer.

It transpired that the charterers of the vessel instructed the master to stow the cargo with ventilation channels not exceeding 10cm. The accepted industry standard for ventilation of this type of cargo, meanwhile, is 30cm.

Similarly, if the master and crew are not familiar with the cargo, advice should be sought from the Club regarding the optimum method of stowage.

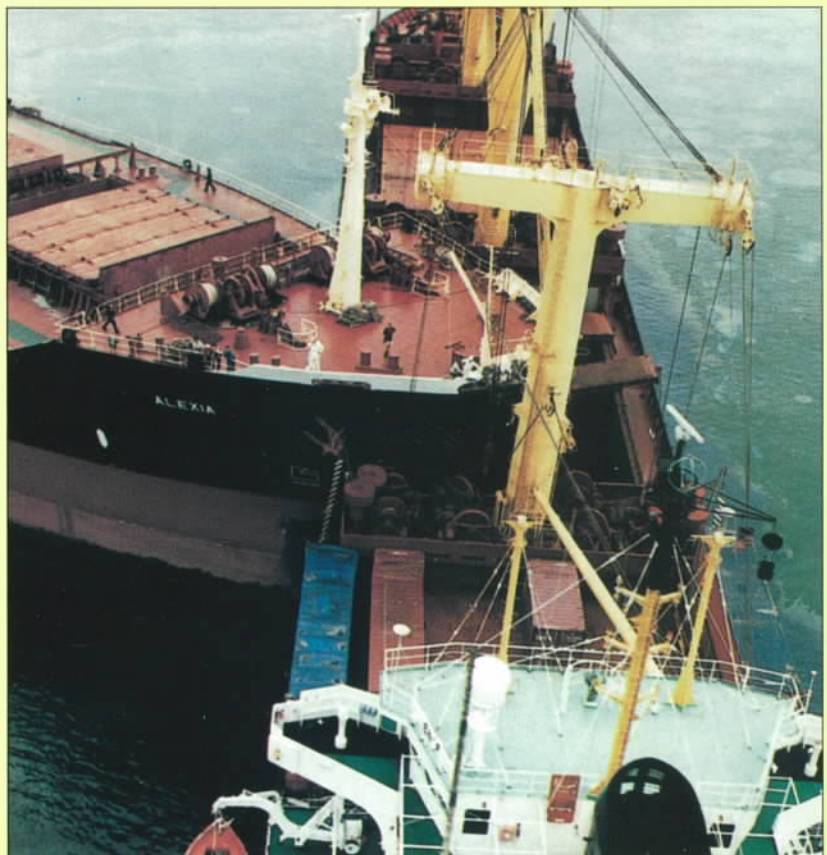
shows what happened recently when a cargoship collided with a bulk carrier entered with the London P&I Club in the south-west pass of the Mississippi River in the United States. Liability has still to be agreed between the parties.

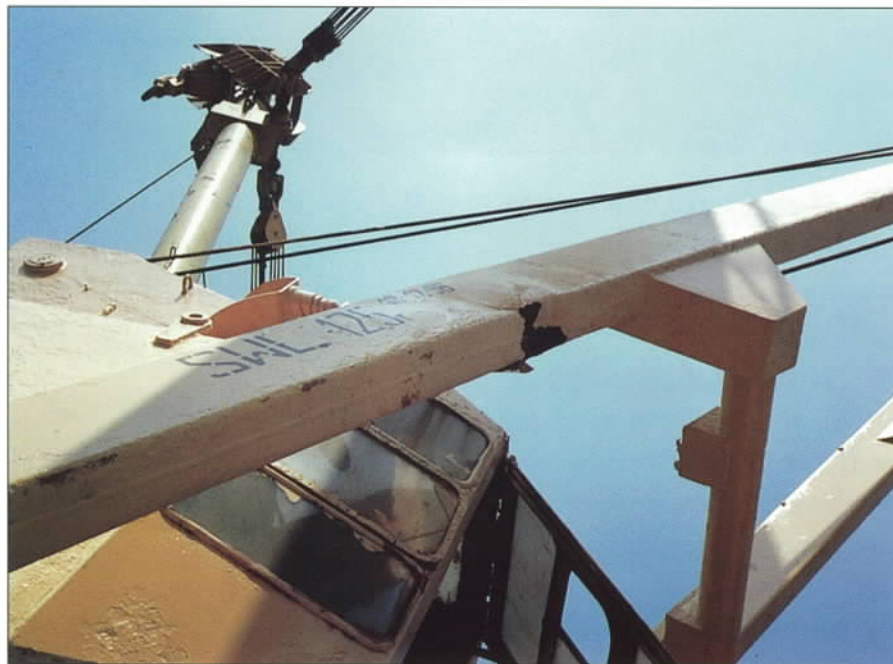
There have been a number of instances of damage as a result of stevedores and/or crew members overriding the

cranes' limit switches. If limit switches are being overridden, or are simply not working, intolerable pressure can be placed on the crane jib and other parts of the structure. The potential consequences are extremely serious.

Apart from damage to the cranes themselves, there is the risk of damage to cargo

Officers and crew must exercise vigilance to ensure that limit switches are operating properly and are not being overridden.

In the event of irregularities, the vessel must make a protest and, if there is any danger to life, they must

order cargo operations to be stopped.

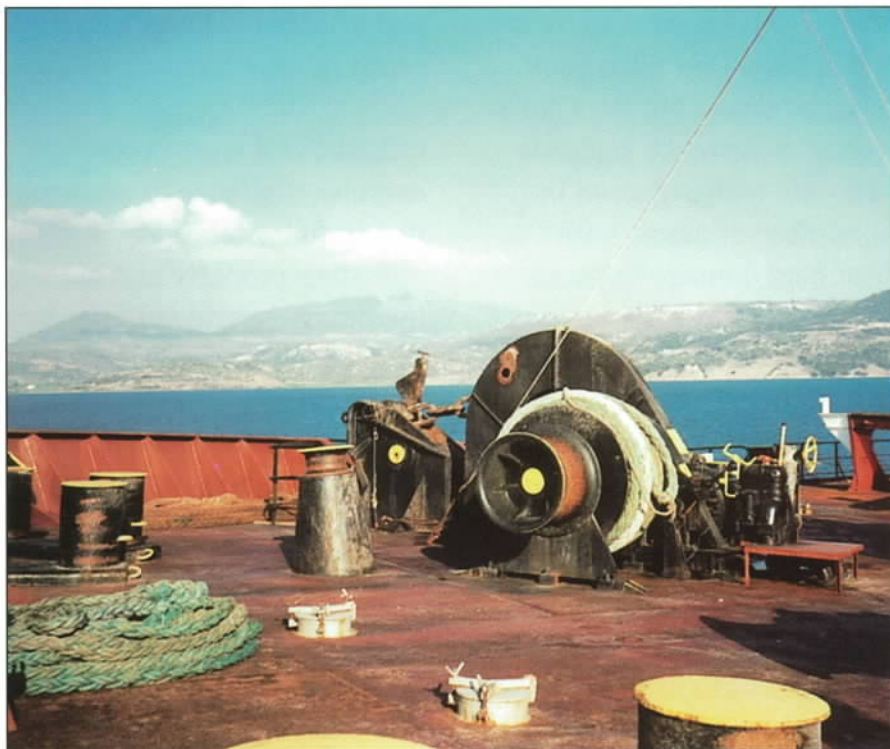
IT is not unusual for tug lines to part. Thankfully, it is rare for this to give rise to a major incident, although records show that this does happen.

- The officer in charge should inspect the line closely for general condition.
- Any doubts about the condition should be reported to the master.

- If necessary, the master should require the tugs to change lines.
- If an unsatisfactory line is offered and cannot be changed without endangering the ship, the master should report his concerns to the pilot/tugmaster, and a record should be kept of the details at the earliest possible opportunity.
- The line which is chosen should be in sound condition, and should be the best one available.
- The best line available may not be conveniently sited, but should be moved as required.
- If necessary, a new line should be broken out.
