Warning signals

WARNINGS, no matter how explicit in nature and intent, are sometimes not enough when it comes to trying to effect the safe carriage of goods by sea. A case recently handled by the Club, involving an unusual heavy lift, illustrates the point. It resulted in damage to both vessel and cargo.

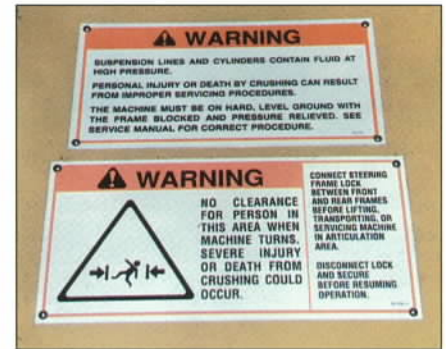
A member's vessel was alongside at Lae, Papua New Guinea, to discharge cargo, including two Caterpillar articulated dump trucks. During unloading, one of the trucks was dropped back into the vessel's cargo hold, onto the after-end of the other

It was subsequently found that the eye plate on the after-end of the lifting spreader had fractured, releasing the sling to the cargo hook. In turn, the forward lifting devices attached to the truck's chassis beneath the engine were torn out, and the truck fell to the bottom of the cargo hold.

The stevedores failed to observe warnings clearly displayed on the truck to clamp the two sections of the body. This, however, was only a contributing cause to the accident. The design of the trucks themselves was a substantial factor. The lifting lugs on the front end of the

trucks were seemingly too close together, rather than being located closer to the corners. This made it very difficult to lift the trucks without the front sections trying to turn.

Despite this design fault, however, the case illustrates the need for stevedores to exercise great care when slinging unusual heavy lifts.

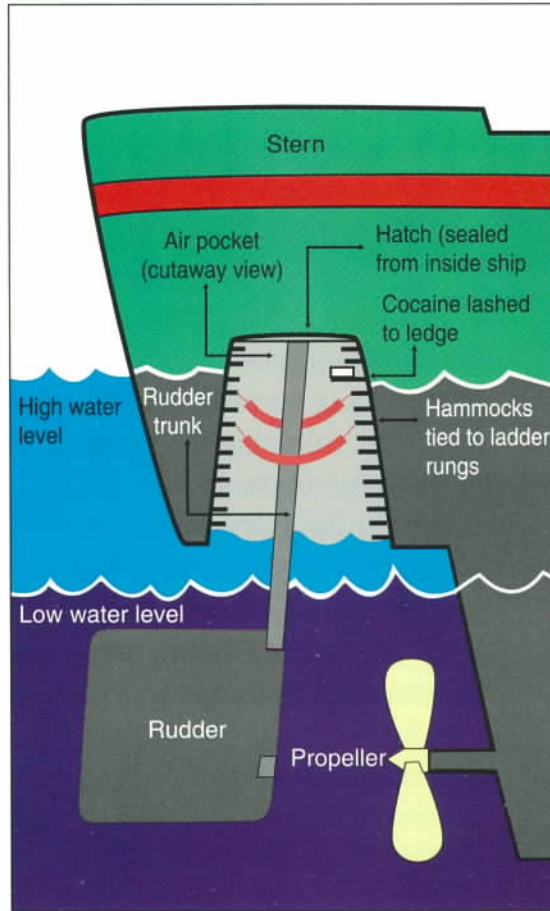
Shortly after the search began, the customs officers found two wet-suited stowaways in the rudder post compartment, together with a duffel bag containing forty-three packages of cocaine valued at more than a million dollars. The two men - both Colombians - are now awaiting prosecution and

The rudder post manhole had not been opened for almost eighteen months. But while the vessel was at Mamanol the rudder post compartment opening was out of the water and accessible by anybody standing on the rudder and

climbing through a 3ft by 6ft opening. As the vessel loaded, the opening sank below the waterline so that it was

possible to enter the compartment under water without being observed.

The incident must serve as a reminder to all owners that, even if they conduct a thorough search of their vessels, they must remain vigilant at all times to the possibility of stowaways gaining access by unconventional means.

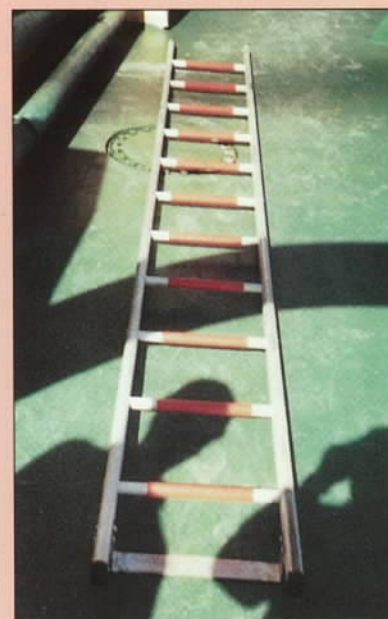
What's wrong with this ladder?

Our photograph shows a ladder which was offered to a US stevedore by the crew of a member's vessel. The ladder had no rubber feet, which is why it slipped, dropping the stevedore as he tried to climb out of a hold where he had been lashing a container.

The man was not badly hurt, but the incident nevertheless produced a claim of more than \$85,000.
