Keeping charts up to date

IN THIS ISSUE

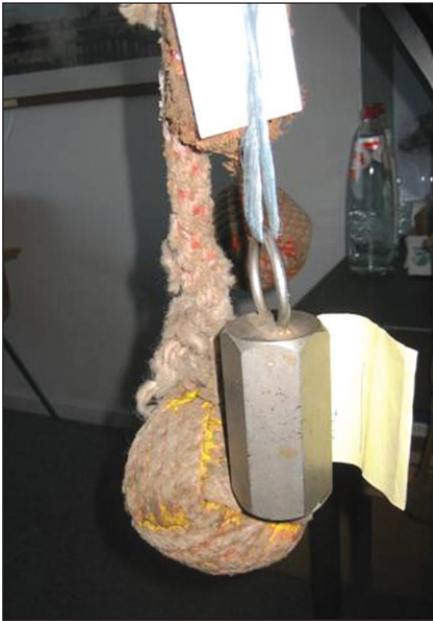
StopLoss would like to thank URS Towage & Salvage in Antwerp for highlighting a worrying practice of seafarers tying dangerous weights to heaving lines which they then throw to (or, perhaps, at) linesmen and tugs during mooring operations. The photograph above shows just one of the potentially lethal weights that URS employees have cut from ships' heaving lines in the past two years. Other examples include shackles and steel hooks.

The traditional method of adding weight to the end of a heaving line is a round knot known as a 'monkey's fist'. The UK Code of Safe Working Practice for Merchant Seamen states, "Vessels' heaving lines should be constructed with a 'monkey's fist' at one end. To prevent personal injury, the 'fist' should be made only with rope and should not contain added weighting material." Clearly, some seafarers find it easier to tie a weight

onto a heaving line than to learn how to form a monkey's fist, but the proper technique is illustrated in the Admiralty Manual of Seamanship published by the Nautical Institute.

If, for any reason, an alternative to the recommended knot is being considered, a sensible option would be to use a quoit (rubber ring) as fitted to SOLAS-compliant rescue lines.

In order to assist members' awareness of the issues, the Club's ship inspections now include a heaving line check as part of the assessment of mooring safety.
