Preventing liquefaction

THE LONDON
P & I CLUB

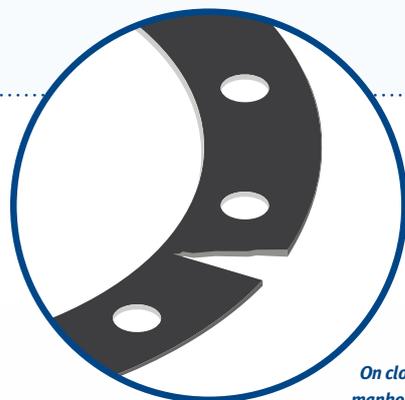
On close inspection, manhole gaskets can sometimes be found to be either perished or split.

The Club reminds Owners to ensure that gaskets and securing arrangements are considered as part of routine Tank Inspections. Whenever a manhole cover is removed, crew should check that it is replaced correctly with a gasket in good condition and tested for integrity, if at all possible.
