Stop Loss

Dangers of overreliance on AIS

Ship inspections
Top five negative findings

Top five negative findings

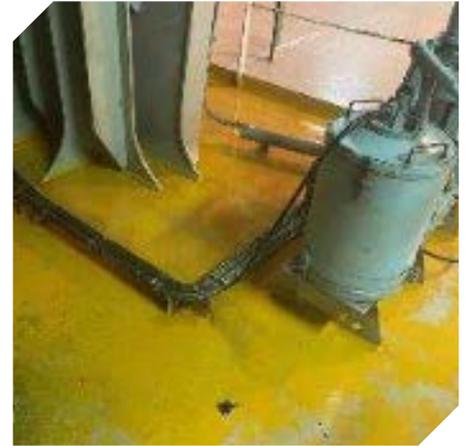
5 IS THE [STEERING GEAR] HYDRAULIC SYSTEM FREE FROM LEAKS?

This is a disturbing finding which presents itself quite commonly during ship inspections. An accumulation of hydraulic fluid in the steering gear saveall is to some extent an indication that problems may exist and an investigation into the source of the leak is necessary. Early detection of the problems that may cause such leaks are important to avoid the potential loss of steering and subsequent groundings or collisions.

Hydraulic fluid accumulated in steering gear saveall

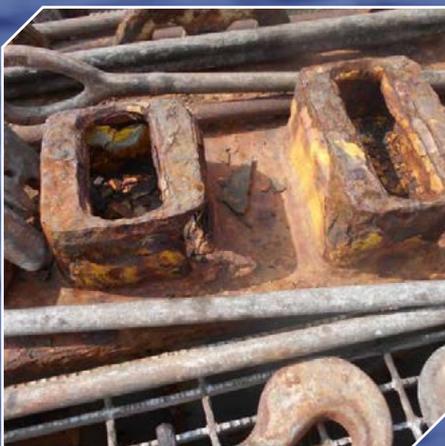
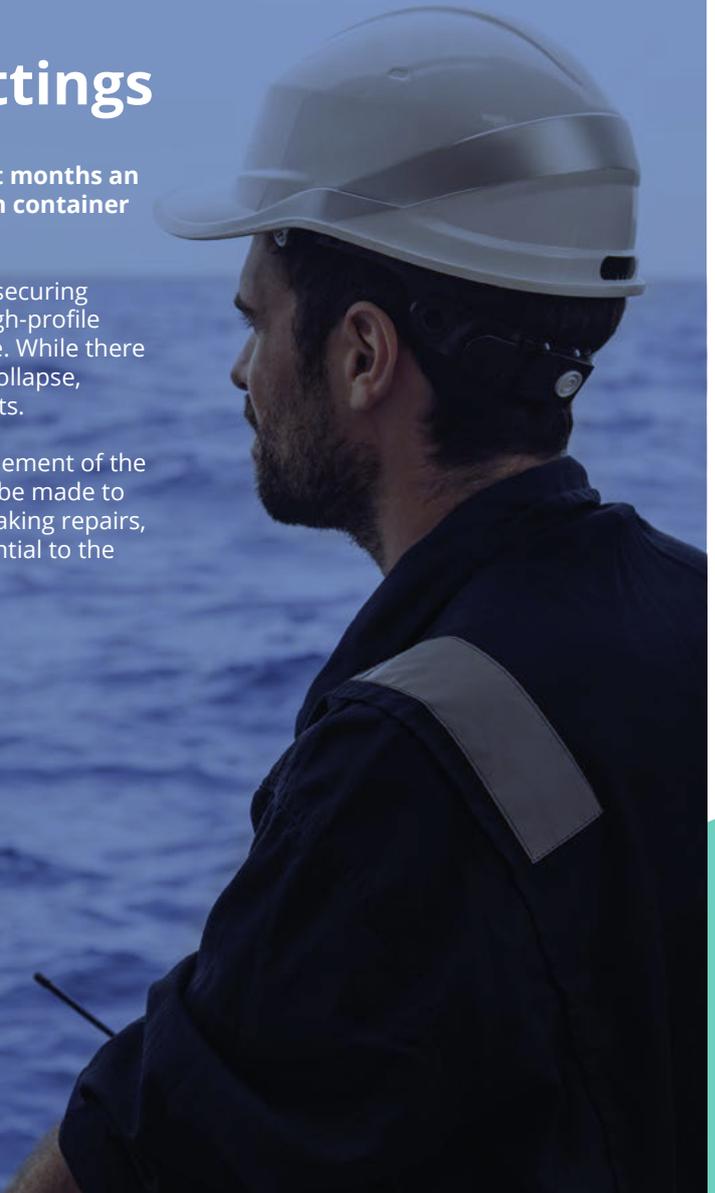
The Club's Ship Inspection Program has noted in recent months an increasing number of negative findings associated with container ship deck fittings and their condition.

Excessive corrosion and thinning can result in a key cargo securing system component being weakened. Container loss is a high-profile subject and is likely to remain so for the foreseeable future. While there are a number of contributing factors to a container stack collapse, weakened deck fittings often feature in investigation reports.

The Club maintains the view that such items, being a key element of the cargo securing system, are Class items and repairs should be made to the satisfaction of the ship's classification society. When making repairs, good quality preparation and welding application are essential to the successful installation of replacement castings.
