Contamination by vapour

Ships' officers should have a good knowledge of their vapour line systems

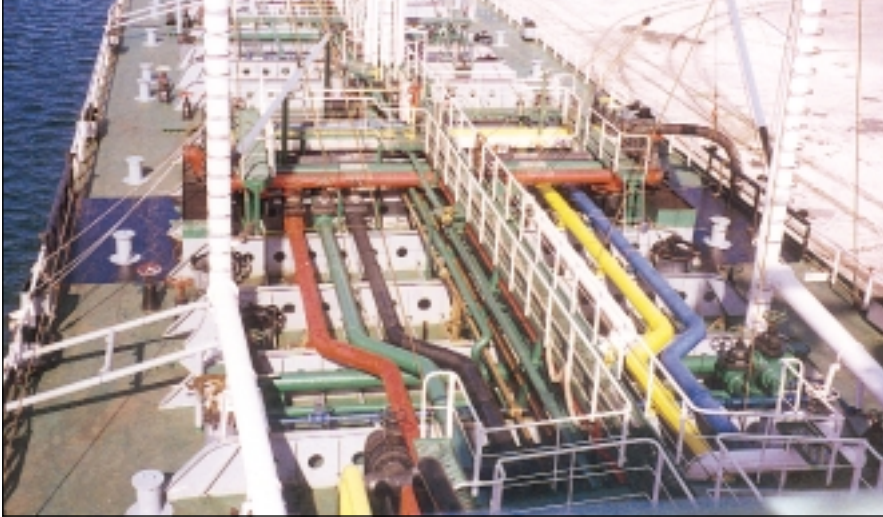
Operators of tankers carrying parcels of high and low - flashpoint cargo concurrently will be aware of the need to keep those parcels separated. But special care also needs to be taken to avoid the risk of contamination due to vapours passing from one tank to another via the inert gas or common venting lines on board their vessels.

Contamination of less than 0.1 per cent by volume in a high-flashpoint cargo, such as diesel, by a low- flashpoint cargo, such as gasoline, may be enough to affect the specification of the diesel-type cargo.

This level of contamination

through vapour lines is not an uncommon occurrence. It can make the cargo unfit for the purpose that it was intended, and it is likely to be rejected by the cargo receivers.

To reduce the potential for such contamination, ships' officers should have a good knowledge of their vapour line system and should, where practicable, consider segregating the lines to tanks containing cargoes which have different flashpoints.

Any segregation or isolation of the vapour lines should comply with all pertinent regulations and with best industry practice, always ensuring that tanks cannot be over or under-pressurised.

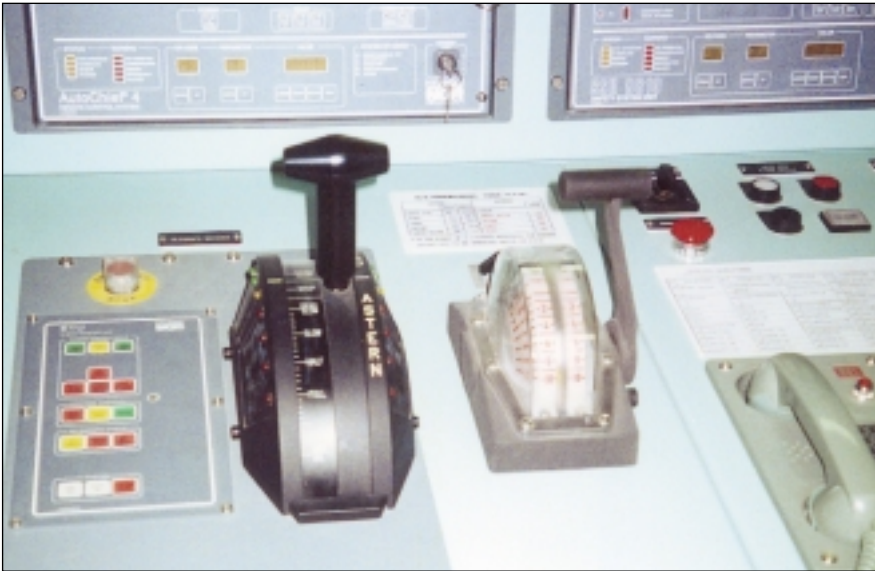
Bridge control main engines - a common factor in Sri Lanka accidents

THE Port of Colombo, Sri Lanka, has experienced several recent incidents where arriving vessels have hit and damaged property, *i.e.*, piers, fenders, cranes etc, and the port has suffered serious consequential losses while berth/equipment repairs have been carried out.

It was found on each occasion that the vessels were being manoeuvred into the harbour, with the main engine on bridge control, when the ship failed to respond as required by the master/pilot.

The Sri Lanka Ports Authority has now issued a circular requiring that, "All vessels which are geared with bridge control main engine manoeuvring systems should change over to engine control prior to arriving at the pilot boarding grounds, and have the engines tested on all manoeuvring speeds for ahead and astern movements. Confirmation of the above should be recorded in the bridge bell book for the pilot's scrutiny."
