Inadequate berth maintenance poses dangers for shipping

Shoreside failings can play a major role in substantial claims

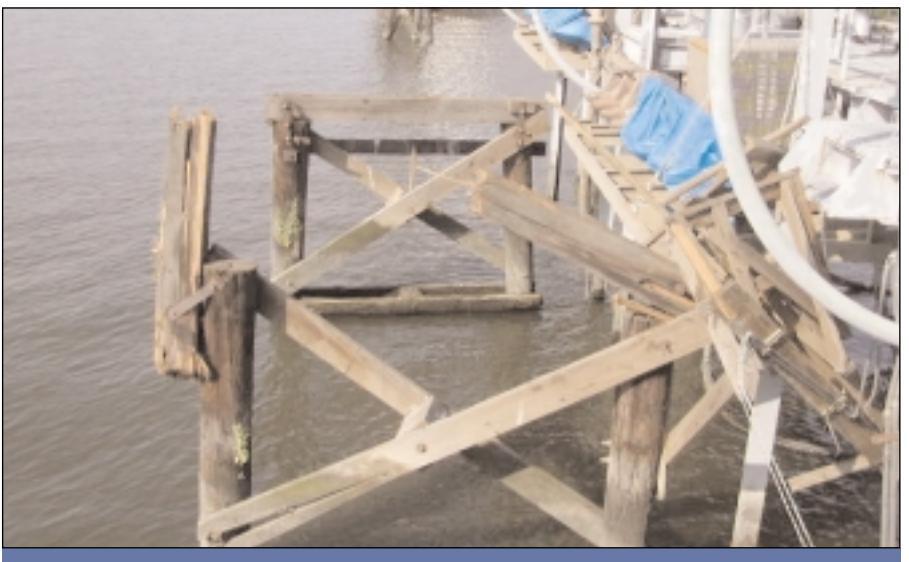
By way of illustration, in a recent case, a Panamax bulk carrier, loading in the US, was warping along the berth *(pictured above)* when a supporting timber dolphin collapsed, together with a 200ft stretch of connecting walkway.

Subsequent investigations revealed the strength of the berth constructed over fifty years ago - to have been severely compromised as a consequence of poor and inappropriate maintenance. In particular, underwater deterioration of the dolphin had led to a significant reduction in its load

In recent months, the authorities have brought legal and criminal proceedings against the owners and masters of two vessels, alleging the incorrect completion of customs capability - jeopardising the safety of the entire structure.

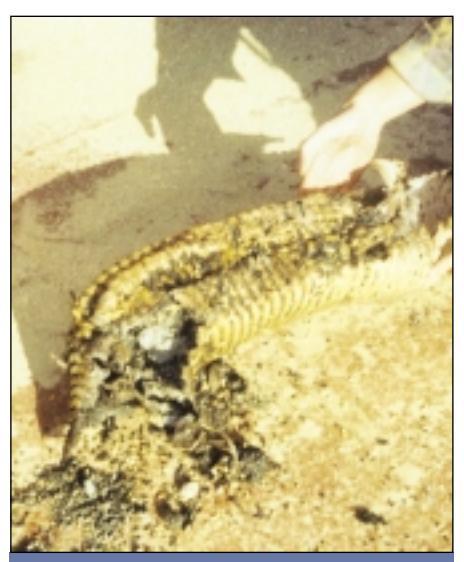
A Club member reports that, following the vessel's loading of a bulk wheat cargo at Lithuania, the fumigant, magnesium phosphide, was inserted inside tubes installed in the cargo holds, which were then sealed. On discharge, one of the tubes, together with the cargo surrounding it, was discovered to have suffered burning damage. It is thought that the burning was caused when undetected ice in the tube melted during the five-week voyage and reacted with the fumigant.

Meanwhile, the remaining undamaged tubes were removed from the holds and placed on deck. However, during subsequent deck washing, the tubes were splashed by water, and started to smoke. As a precautionary measure, the tubes were thrown overboard, after which they exploded, emitting fire and smoke for several minutes.

In this case the master had received no guidance or warnings of the potential for adverse reactions involving the fumigant of the sort experienced during and following the cargo voyage.

However, the IMO publication, *Recommendations on the Safe Use of Pesticides in Ships* - which forms part of the supplement to the IMDG Code - advocates that instructions for the proper disposal of fumigant residues should be provided by the fumigant operator. Further, it outlines procedures for safe fumigation. Masters should be familiar with the IMO's recommendations, and should seek assistance from the local P&I correspondents, in case of need.

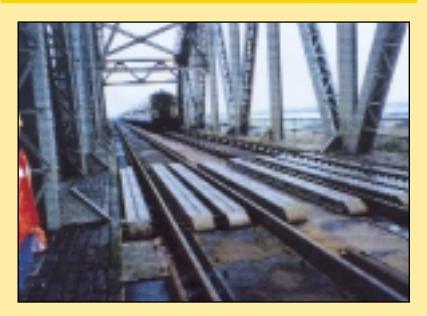
It is not only on the roads that accidents involving access beneath railway bridges can occur. One of the Club's member's vessels was passing through the Kiel Canal when its derrick struck the underside of a bridge, causing the railway line to be damaged. The incident resulted in the suspension of rail services for a number of days, and the member had to deal with the problem of claims from both the canal authority and the railway company.

The claims emphasise the need for care in checking air drafts. In this case, although checks had been made, the resulting calculations were flawed because the derrick was extended higher than shown on the ship's plans. The photograph *(left)* shows, in the foreground, the steel beams which were installed alongside the rails as part of the temporary repairs which were effected to help maintain the rail service following the accident.

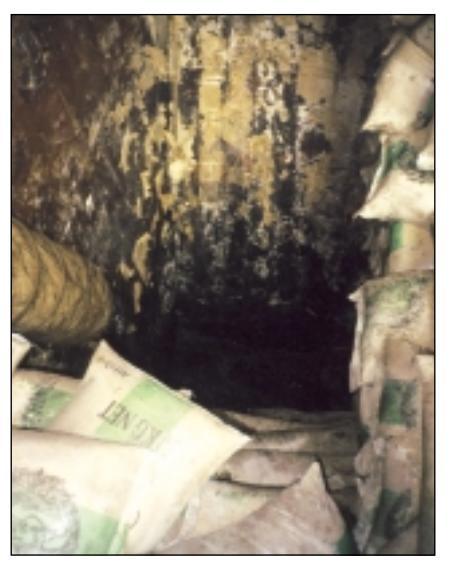
In each case, regular cleaning and testing of the pumping arrangements had been performed. However, just prior to the claims arising, both vessels had carried cement cargoes lumped residues of which were subsequently discovered in their bilge suction pipe systems as well as sounding pipes in a number of holds. These residues resulted in a variety of difficulties including :

• Screw-down non-return valves were tightly shut with lumps of cement remaining on the valve seat, resulting in leakage and, in one case, causing the shaft of the valve to bend.

• Normal non-return valves failed due to cargo residues impeding their proper operation.

• Sounding pipe bottoms became clogged and blocked, preventing the ingress being detected.

Chris Hewer, Merlin Corporate Communications, 11 Kingsland Court, Three Bridges Road, Crawley RH10 1HL, UK Tel: +44 (0) 1293 55 00 44 Fax: +44 (0) 1293 55 04 04 E-mail: wizard@merlinco.com A combination of these problems gave rise to partial flooding of a hold on each of the vessels, leading to substantial claims for damaged cargo *(see photo left)*. Members are encouraged to advise ships' staff of these experiences and to urge particular care in the removal and cleaning of cement residues from holds and bilges.
