A timely reminder on ventilation practice

Proper ventilation and stowage are vital to the safe carriage of bagged cargoes

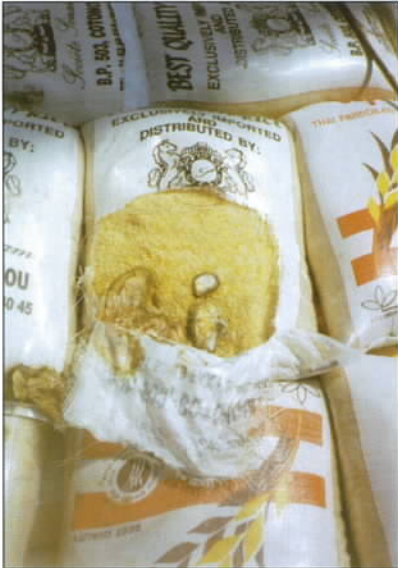
Large amounts of moisture can be released into the hold atmosphere by such cargoes and, in certain conditions, high humidity levels can lead to formation of condensation (commonly referred to as "ship's

sweat") on the vessel's structure. Damage to the cargo often results if the bags come into contact with that condensation. The formation of this ship's sweat can be minimised by correctly ventilating the holds.

In order to ascertain whether ventilating the holds with outside air is appropriate, ship's officers must compare the dew point of the air inside the hold with the dew point of the external air.

If the sea conditions are suitable and the dew point of the external air is lower than that of the hold air, then the holds should be ventilated. Conversely, the vessel's holds should not be ventilated if the dew point of the external air is higher than that of the air in the hold.

The dew point comparisons should be made frequently, say once every four hours, conditions permitting, throughout the voyage and the ventilation should be adjusted in accordance with the outcome of those regular comparisons.

A detailed record of all ventilation carried out during the voyage should be kept in the logbooks for future reference.

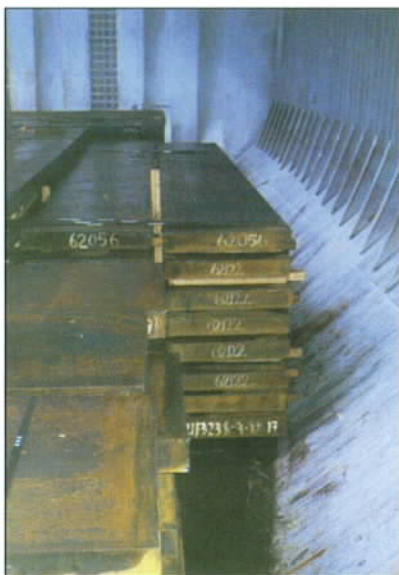
Designed for quick discharge - but is it safe?

developed in order to help minimise stevedore costs when carrying semi-finished steel slabs. The California Block Stow is designed so that slabs can be discharged quickly using large gantry cranes. While it may be well-suited to vessels with box-shaped holds, the Club is not persuaded that this type of stow can be safely used in self-trimming bulk carriers.

- The top three tiers are lashed together to form a "cap".
- Between the bottom tier and the cap, the block is held together solely by the frictional bond between the slabs and the wooden dunnage that is laid between each tier.

Given the potential for the slabs to shift, members should be aware of the dangers in the event that use of California Block Stow is proposed, either during fixture negotiations or prior to loading slabs.

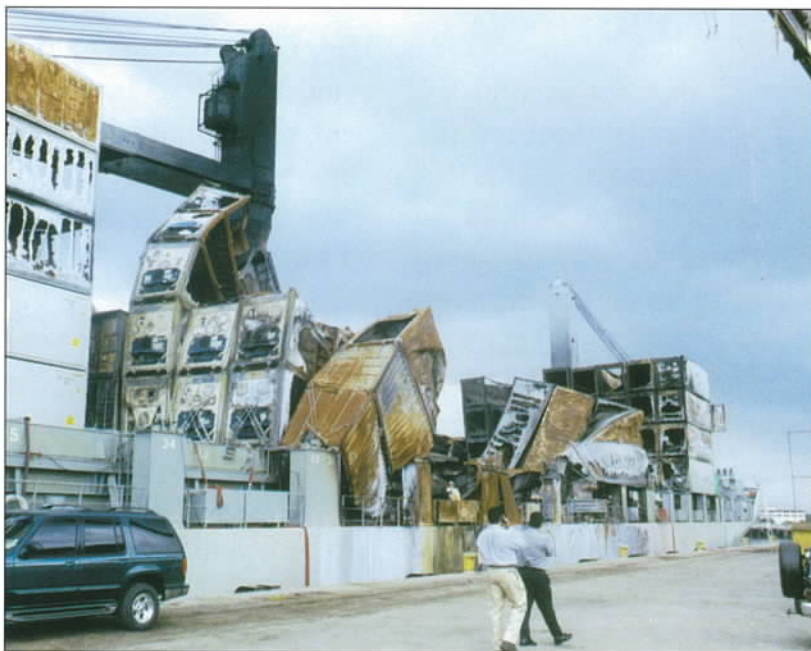
IT is now thought that the number of shipboard fires which may be attributable to the carriage of calcium hypochlorite is higher than was previously widely understood, and that IMDG Code requirements for the carriage of this cargo are inadequate.

The number of CH-related ship fires is greater than previously thought

The International Group of P&I Clubs has issued interim recommendations for the carriage of these cargoes (UN 1748, 2208 and 2880), which have already been circulated to members in Club circular number 5:286, and further details can be obtained from the Club's website. Club members are reminded that, in addition to the

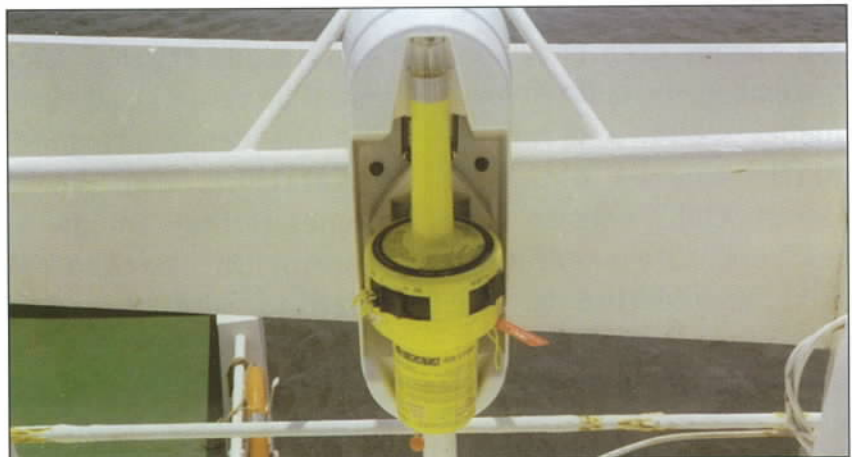
OPERATING or testing errors of Digital Selective Calling equipment and Electronic Position Indicating Radio Beacons (*above*) can result in false distress signals being transmitted which cause problems and impose a burden on rescue co-ordination

centres and search & rescue services. They use up valuable resources and can cause life-threatening delays when real emergencies arise. So it is essential that all relevant ships staff can correctly operate, test and clean any radio equipment capable of transmitting an automated distress signal.
