Increase in stowaway incidents

THE LONDON
P & I CLUB

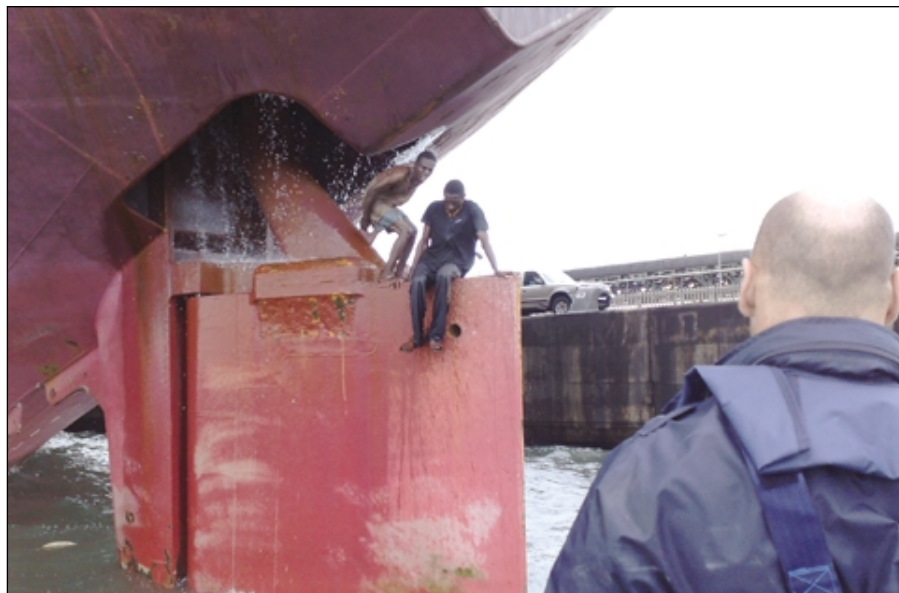
Although the increased number of cases is not obviously associated with any particular country or nationality, the 2008 incidents included two occasions on which stowaways from Lagos, Nigeria were found hiding in rudder trunks. In both cases, the stowaways were discovered and detained as they descended from their hiding places at the ship's next port of call. Presumably,

the men gained access to those hiding places having come under the stern in a small boat.

The most remarkable aspect of these cases is that the men survived the sea passage. Almost certainly there are cases where stowaways hide in a rudder trunk only to perish at sea without the crew ever being aware of their presence. The willingness of stowaways to use such a dangerous hiding place appears to have taken the crew in each recent case by surprise.

Company and ship security officers are therefore reminded that their risk assessments should include a review of the dimensions of the rudder trunk. If stowaway access is achievable, then members should consider whether it is possible to retrofit a metal grill to prevent entry and to conduct searches of the area prior to departure from port.

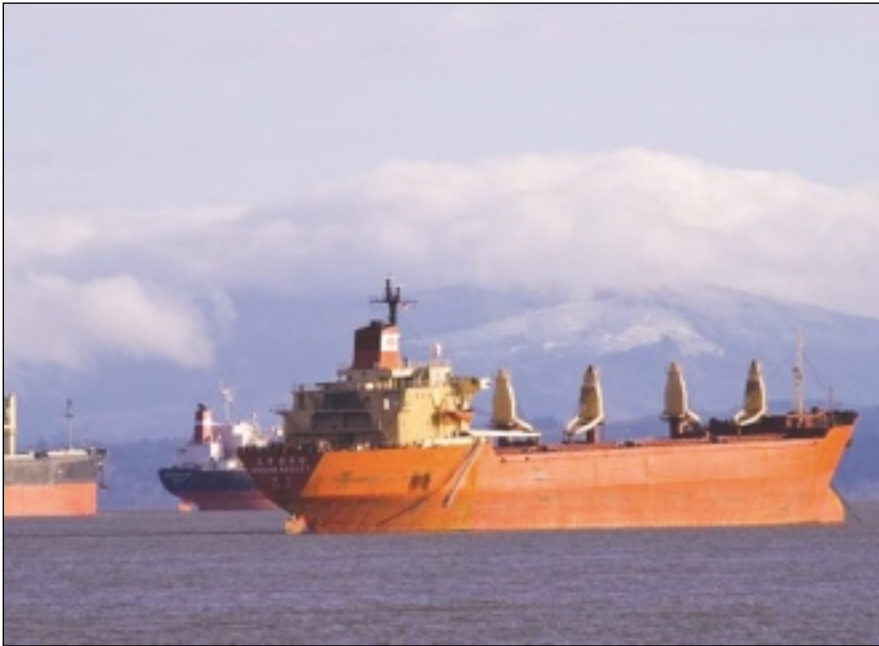
The ongoing analysis of claims handled by the Club has highlighted the number of collisions that arise in anchorages, particularly those that are subject to strong currents or tidal flow.

A typical case involves a ship manoeuvring at slow speed which is set down upon an anchored vessel. The Club has assisted members in several incidents on behalf of both anchored and colliding ships. Often a collision occurs when a ship is in the process of dropping anchor. The Club's analysis of these incidents often suggests that the bridge team on the moving ship was fully aware of a strong cross-current but failed to appreciate that a steady current would have a greater impact upon the ship's track as its speed reduced. Moreover, opportunities to monitor cross-track error by parallel indexes were often missed. Other incidents involve contact after

a ship drags anchor. In some cases, the bridge team had misjudged how

little time would be available to arrest the ship's movement if the anchor dragged given the close proximity of other anchored ships. Occasionally, the risk of collision was increased by a failure to monitor the ship's position carefully. In more than one case, the colliding ship appears to have realised that it was dragging towards another ship only when that ship made VHF contact. Again, the radar could have provided early warning of the danger had an appropriate guard ring been set up. Many of the incidents reviewed by the Club precede the recent market difficulties which have led to a significant increase in the number of ships at anchor off busy ports. The greater risk associated with increased congestion reinforces the need for bridge teams to follow best practice in passage planning and watch-keeping.

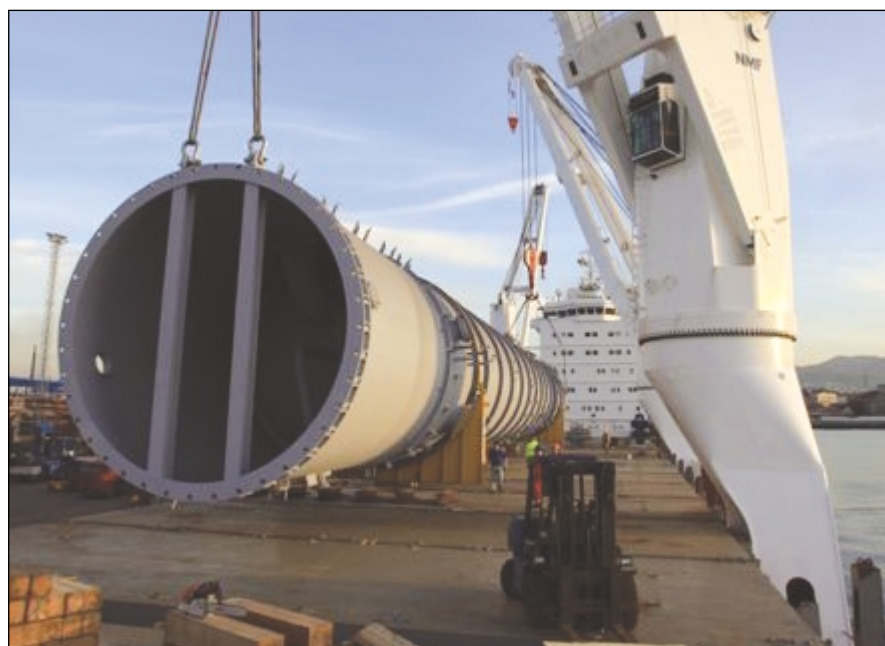
The Club has recently reviewed several cases involving carriage of deck cargoes, which have highlighted a range of operational and coverage issues. Although carriers are often able to exclude liability for loss of or damage to deck cargo, there have been cases in which they have nevertheless been asked to plan and execute the securing on deck of large and heavy units.

On one occasion a member was concerned that the crew would benefit from assistance in applying the principles set out in the IMO Code of Safe Practice for Cargo Stowage and Securing and the ship's Cargo Securing Manual. In addition to referring the member to *Lashing and Securing of Deck Cargoes*, published by the Nautical Institute, the Club was able to suggest a consultant experienced in 'project cargo' sea-lashing plans. In another

case in which valuable deck cargo was badly damaged in heavy weather, the owner had issued a bill that did not seek to exclude the carrier's liability for any loss of or damage to the deck cargo. Apparently, that owner had been unaware that the failure to exclude liability potentially prejudiced Club cover and was also not aware that market insurance would have been available in respect of any liabilities that fell outside P&I.

The Club should be able to help members identify useful technical guidance or expertise in the event of questions arising over cargo lashing. And members should not hesitate to approach their usual Club contact or to seek assistance via stoploss@londonpandi.com should any clarification be required of the insurance implications arising from the ondeck carriage of cargo.
