The London P&I Club

STOP Loss

OCTOBER 2014 | ISSUE 63

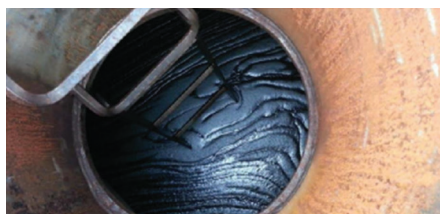
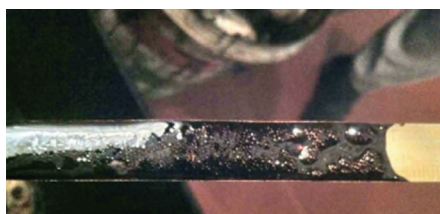
The Cappuccino effect may be described essentially as the frothing or bubbling effect caused by compressed air blown through the delivery hose. The aerated bunkers when sounded will give the impression that the fuel is delivered as ordered. In fact, after some time when the entrapped air in suspension settles out of the fuel oil, the oil level drops and a shortfall is discovered.

- Signs of froth/foam on the surface of the fuel in the barge tanks during opening gauge
- Excessive bubbles on the sounding tape prior to, during and after bunkering
- Bunker hose jerking or whipping around
- Slow delivery rates than those agreed
- Gurgling sound in vicinity of bunker manifold
- Fluctuations of pressure on manifold pressure gauge
- Unusual noises from the bunker barge

- During usual gauging of bunker barge tanks, fuel oil from ullage hatches should be visually checked for any foam on the surface.
- Foam may also be detected on the ullage tape.
- If entrained air is suspected on the tape or fuel surface, obtain a sample and pour into a clean glass jar and observe carefully for signs of foam or bubbles. If the suspicion is confirmed, the Chief Engineer should not start bunkering and should notify the Owners/Charterers immediately.

Air can also be introduced in the fuel during the pumping period, so it is important to continue gauging the ship's tanks as air bubbles would be readily seen on the sounding tape. As stripping and line blowing can also introduce air, stripping should only be performed at the end of the delivery for a short period of time and line blowing kept to a minimum. The ship's bunker manifold valve should be checked shut before gauging of the ship's tanks.
