Protecting the Barrier Reef

Innovative wreck removal pays off

Point of lashing

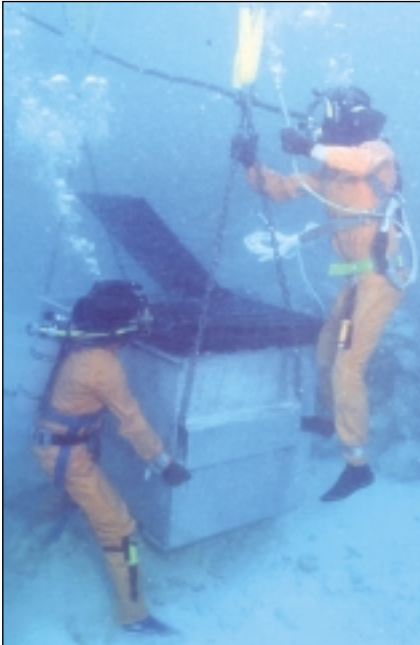
Photo by Dr Paul Marshall, Great Barrier Reef Marine Park Authority

As a result of the grounding, the coral reef sustained physical damage to its topography, as well as chemical damage resulting from the release of tributyltin (TBT) anti-fouling paint, which was scraped from the vessel's hull and spread over a large area. In view of the remedial work that the Barrier Reef

Working in harness with the authorities, a clean-up programme involving the removal of substantial coral boulders for temporary storage on a barge, followed by a process of vacuuming over a wide area to reduce the TBT concentration to acceptable levels, was agreed and adopted.

Although the operation was partly hampered by the tropical cyclone season, the authorities and the owners' approach meant that an effective clean-up was concluded in 50 days. The coral boulders were replaced once vacuuming was completed, and subsequent testing showed that the vacuuming had achieved the required reduction of toxicity levels in the area. The exercise was deemed a success by the authorities, who will continue to monitor the reef with a view to demonstrating the value of the removal of the TBT, over the longer term.

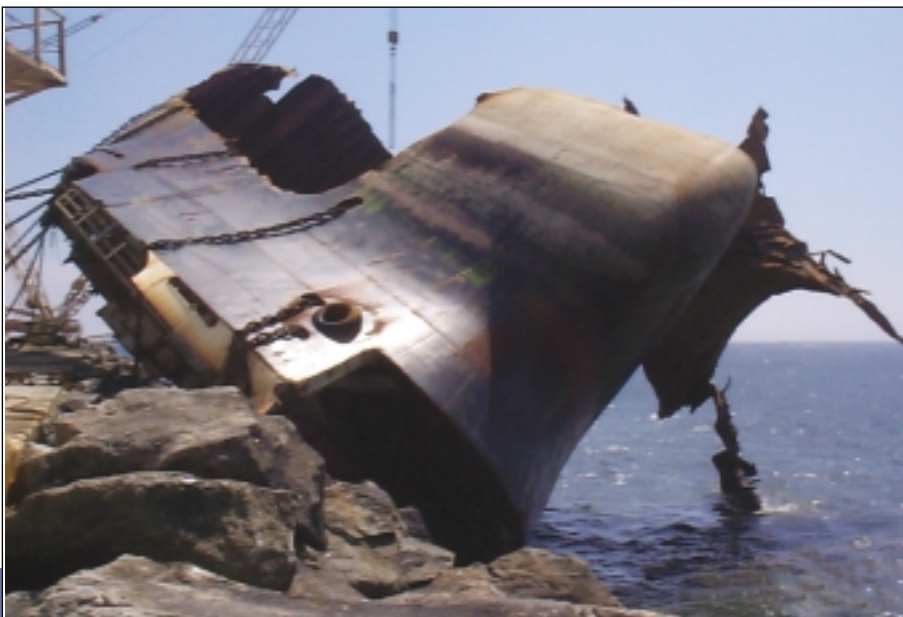
A RECENT incident involving the loss of a member's vessel in Spain resulted in an unusual wreck removal operation. (see photo below).

declared a CTL. Following removal of the deck and underdeck cargo, the wreck was removed using an innovative system of linear chain pullers which moved the wreck on its side, in two sections, onto the breakwater, where it was cut up for disposal.

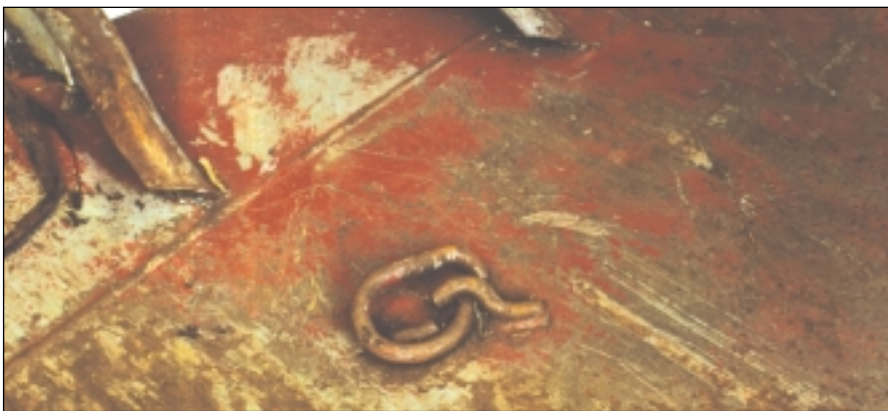
Prior to use, and taking into account the weight of cargo to be secured, lashing points should be assessed for design strength and purpose, as well as for damage and any corrosion weakness. Ship's staff should have knowledge of lashing point strengths and of any restriction in the manner in which lashing points are used. Most lashing points are designed to withstand being pulled in predetermined directions, but, when pulled

from the wrong direction, shearing forces can lead to them failing.

Proper training will help avoid failure of lashing points

Classification societies should approve the attachment of lashing points such as plates, lugs, pad-eyes or D-rings to watertight bulkheads or other structures, ensuring that the points are not so strong as to compromise the ship's structure or plating.

The ship's securing manual should contain details of all lashing points, their design strengths and guidelines for their use. It is also wise to colour-code lashings and lashing points to indicate safe working loads.
