Stop Loss

Dangers of overreliance on AIS

Ship inspections
Top five negative findings

Top five negative findings

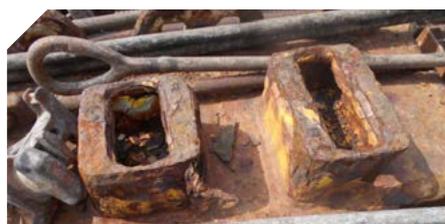
Container ship
deck fittings

The Club's Ship Inspection Program has noted in recent months an increasing number of negative findings associated with container ship deck fittings and their condition.

Excessive corrosion and thinning can result in a key cargo securing system component being weakened. Container loss is a high-profile subject and is likely to remain so for the foreseeable future. While there are a number of contributing factors to a container stack collapse, weakened deck fittings often feature in investigation reports.

The Club maintains the view that such items, being a key element of the cargo securing system, are Class items and repairs should be made to the satisfaction of the ship's classification society. When making repairs, good quality preparation and welding application are essential to the successful installation of replacement castings.

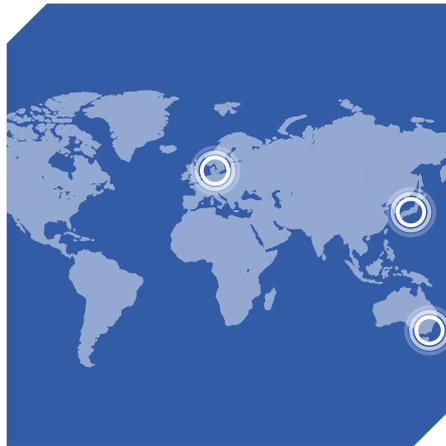
***Iron Chieftain* ATSB – Australia**

On 18 June 2018, during cargo discharge operations while alongside at Port Kembla, New South Wales (NSW), a fire broke out in the internal cargo handling spaces of the self-unloading (SUL) bulk carrier *Iron Chieftain*.

The ATSB investigation concluded that the fire originated in *Iron Chieftain's* C-Loop space and was likely the result of a failed bearing in the ship's conveyor system which created the heat necessary to ignite the rubber conveyor belt. The ATSB also determined that the ship did not have an emergency contingency plan for responding to fire in the ship's SUL spaces and that there were technical failures of the

The ATSB found that the risk of fire in *Iron Chieftain's* C-Loop space was identified and documented by the ship's operators, CSL Australia, as being unacceptable about five years before the fire. This risk rating was primarily due to the absence of an effective means of fire detection and fire suppression for the SUL system spaces. However, measures taken to address the risk were either inadequate or ineffective.

The ATSB also identified that the regulatory oversight of *Iron Chieftain* did not identify any deficiencies related to the safety factors identified by this investigation, or to the ship's inherent high fire safety risk and management of that risk.
