## Take care when mooring

**T**he Club has recently seen a tragic case emphasising the very close care and attention required - on board and ashore - during the mooring and unmooring of ships.

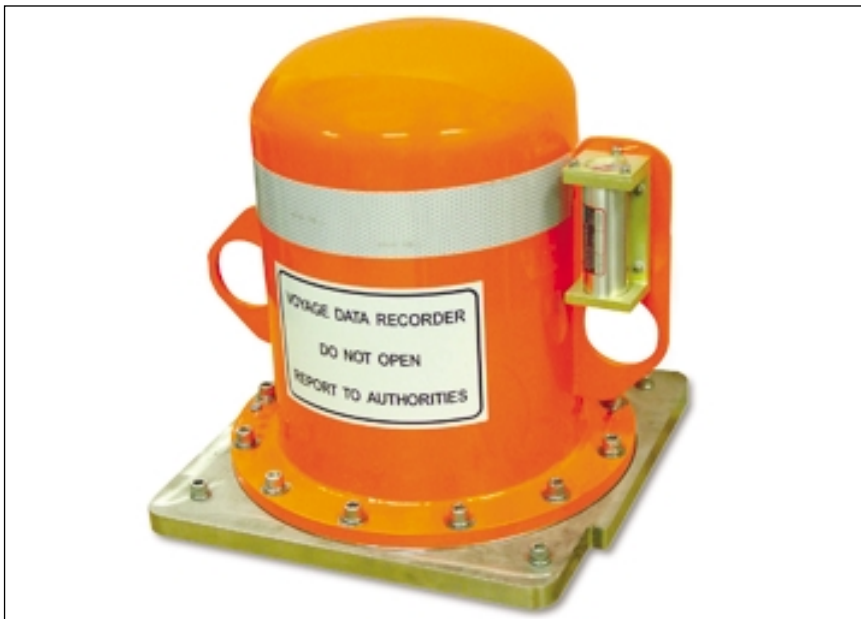
## VDR impact on casualty investigation

**R**ecent reports - including those accessible at: [www.maib.dft.gov.uk](http://www.maib.dft.gov.uk) - illustrate how Voyage Data Recorders (VDRs) can perform a similar role in the investigation of shipping casualties to that of so-called 'black boxes' in the context of accidents involving aircraft.

For example, in one collision case, the flag state investigators' understanding of the cause appears to have been significantly assisted and accelerated by downloading and analysis of information recorded on the VDR of one of the ships. The VDR recording included video output of the ship's primary radar, enabling the investigators to view
