Passing the can test on nickel ore cargoes

StopLoss 42 (May, 2006) featured an article by Brookes Bell Jarret Kirman which highlighted the propensity to liquefy of nickel ore mined in Indonesia and the Philippines.

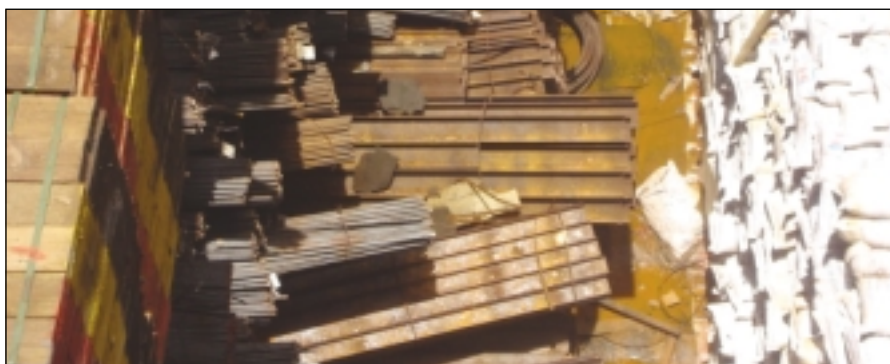
Already there have been several cases in which ships loading multiple holds were caught out by sudden downpours. In each case a significant amount of cargo in the holds was badly wetted while the crew closed the hatch covers.

(Wallem Shipping Vietnam)
