Keeping charts up to date

IN THIS ISSUE

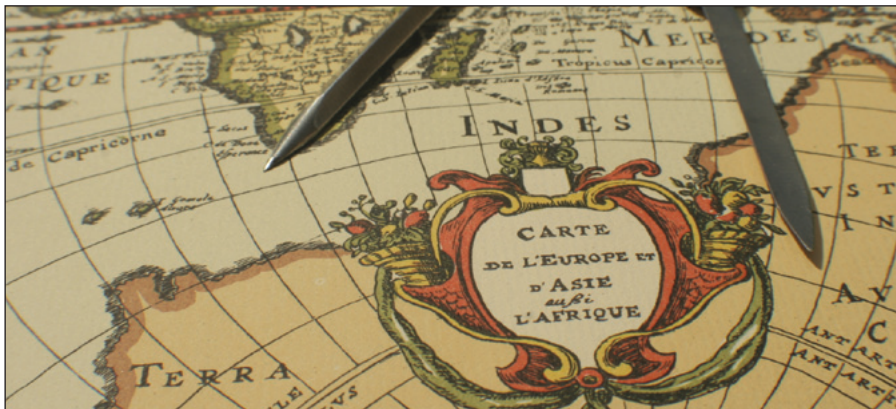
Yet, from time to time, the Club receives a report from a ship inspector that the charts or other nautical publications on an entered ship are out of date. Two incidents reviewed recently by the Club emphasise why compliance with the requirement is imperative.

In the first case, a telecommunications company alleged that a submarine cable had been damaged by a ship's anchor.

The first assumption was that, if the anchor had contacted the cable, then it must have been because it was dragging and the ship had not been able to recover the anchor in due time. However, the Club-appointed surveyor quickly established that the ship had, in fact, anchored directly over the cable

but that the bridge team had been completely unaware of the hazard beneath them. The surveyor identified that the ship had used an old edition of the chart, which predated the laying of the cable. Apparently, on preparing the passage plan, the second officer had not checked that he had the current edition of the chart.

In the second case, the investigation into the circumstances in which a ship suffered damage as it struck a hazardous wreck confirmed that the current edition of the chart was in use but that it had not been properly corrected. A chart correction showing the wreck had been issued some three years previously.

Any member interested in obtaining details of refresher courses for their seafarers on chart and publication management is welcome to contact the Club for suggestions. Moreover, the UK Hydrographic Office publishes 'How to keep your Admiralty Charts Up-to-Date', which is a recommended read for ships using British Admiralty Charts.

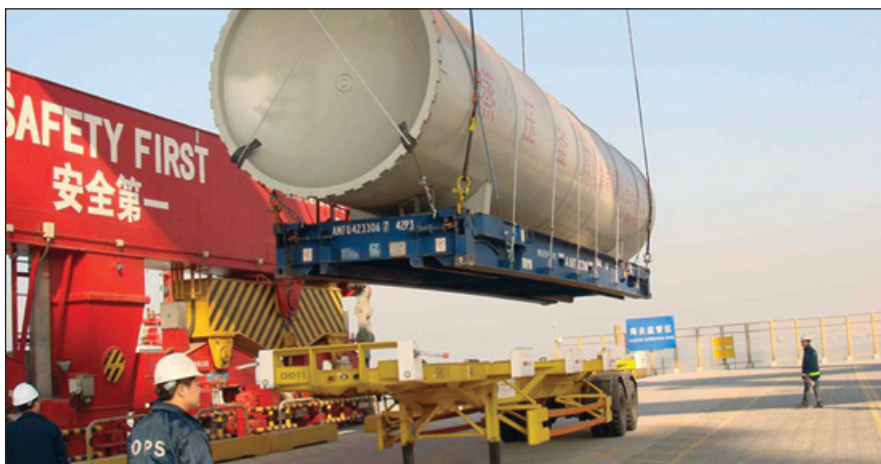
The Club has recently reviewed two significant cargo damage claims which highlight the need to plan properly the lifting operations for heavy or unusual cargoes.

In one incident, a piece of machinery was to be loaded as an 'out of gauge' unit on a flat-rack container. A conventional spreader could not connect directly to the four corner-posts on the flat-rack because the top of the equipment was higher than the posts. A conventional method of lifting such a unit would be to connect the corner-posts to the spreader, using suitable wire strops and shackles. But, for reasons that are not clear, the shippers tried to load the container using a portable crane fitted with a cargo hook, rather than using a gantry crane fitted with a spreader. The stevedores rigged chains from each corner-post to a 'D' ring on the cargo hook. The container was not designed to be lifted from a central point. The corner-posts snapped as the container was being loaded and both the machinery and a hatch pontoon were damaged when the flat-rack

dropped. Luckily, there were no injuries. In the second incident, the investigating surveyor reported that, unusually, suitable lifting wires were not supplied with a substantial item of project cargo. Moreover, the ship's staff did not develop a formal lifting plan prior to the attempted discharge. The lift appears to have been attempted using strops that were simply not fit for purpose. Fortunately, the wires parted more or less immediately and the cargo was not badly damaged by the short drop.
