Preventing liquefaction

THE LONDON
P & I CLUB

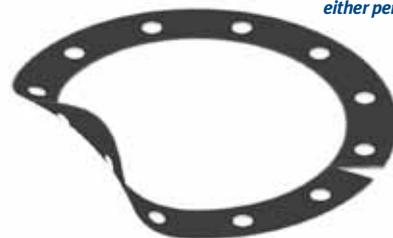
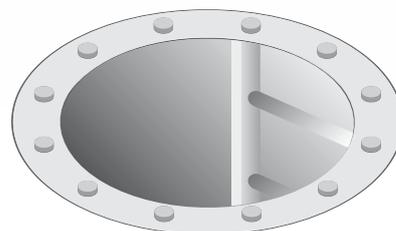
On close inspection, manhole gaskets can sometimes be found to be either perished or split.

The Club reminds Owners to ensure that gaskets and securing arrangements are considered as part of routine Tank Inspections. Whenever a manhole cover is removed, crew should check that it is replaced correctly with a gasket in good condition and tested for integrity, if at all possible.
