# REDUCING THE RISK OF PROPULSION LOSS

Operational guidance for preventing  
blackouts and main engine failures

The London P&I Club

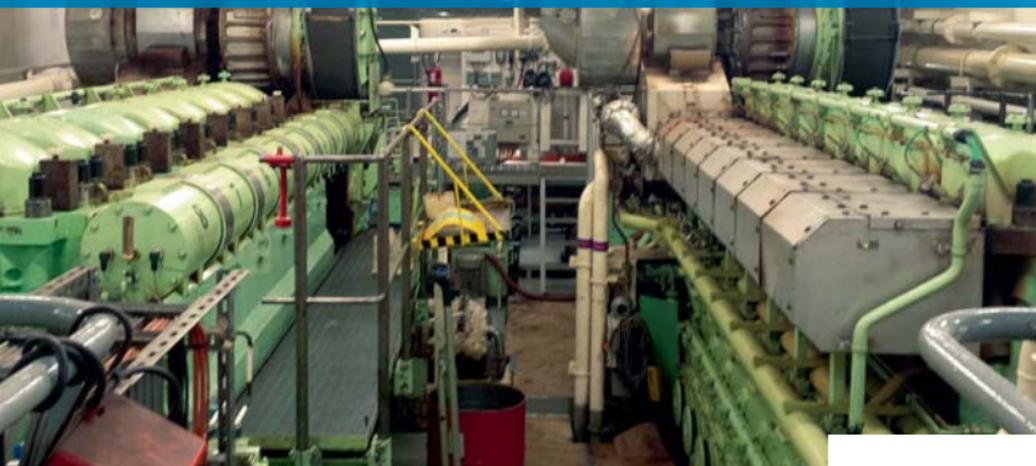
▲  
*Modern engine room with two medium speed main engines*

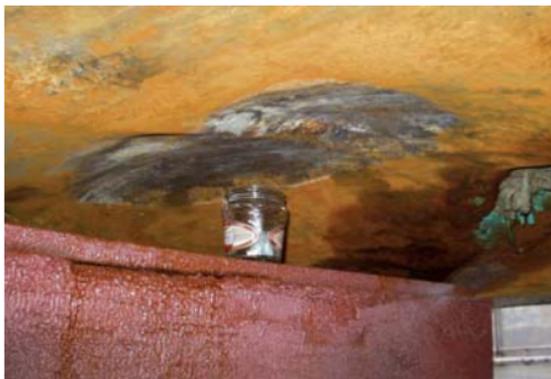
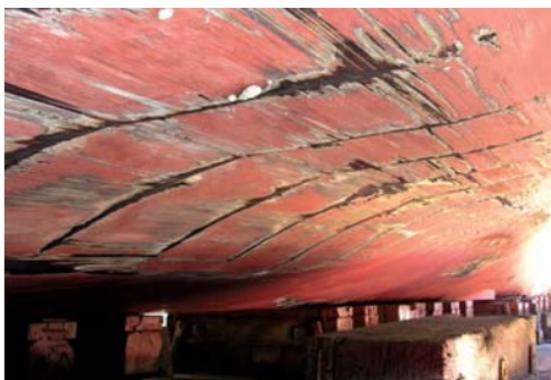
▲  
*Bottom damages as a consequence of machinery failures<sup>1</sup>*

<sup>1</sup> On the top photo, the glass jar is here to highlight the degree to which the shell plating is set in.

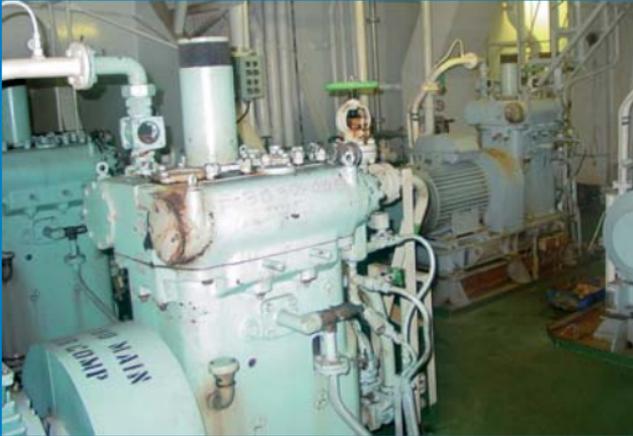
*Typical air compressors on a vessel*

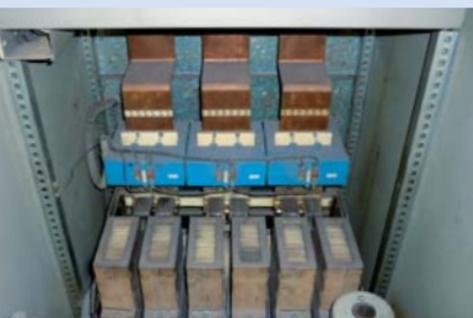
▲ *Digital and thermal images of a switchboard breaker fault*

- A regular thermographic survey of the switchboard should be carried out to monitor for loose connections or overheating equipment.
- The alarm printer, where fitted, should be maintained correctly, such that the printout is legible, as this is often a valuable source of information regarding the cause of the blackout.

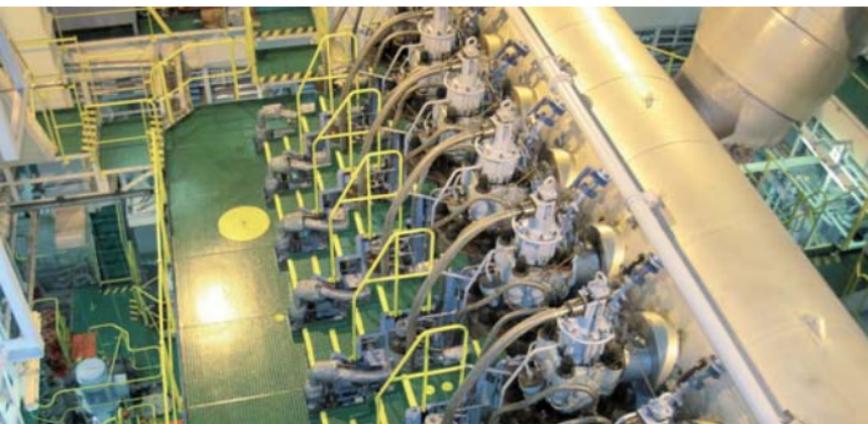
▼  
*Top platform of a large slow speed marine engine*
