REDUCING THE RISK OF PROPULSION LOSS

Operational guidance for preventing
blackouts and main engine failures

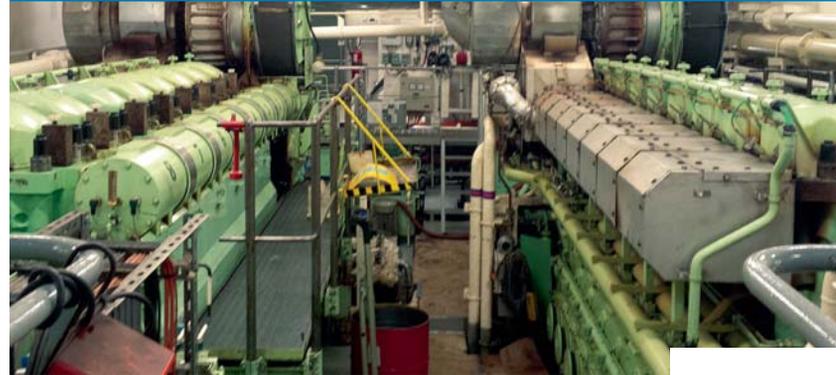
▲
Modern engine room with two medium speed main engines

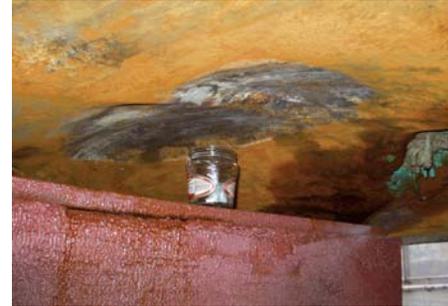
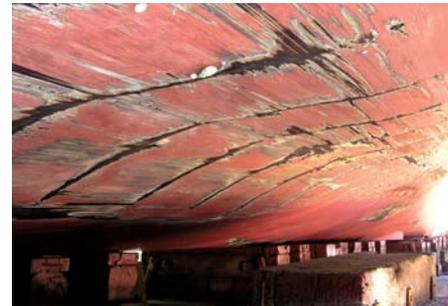
Bottom damages as a consequence of machinery failures¹

¹ On the top photo, the glass jar is here to highlight the degree to which the shell plating is set in.

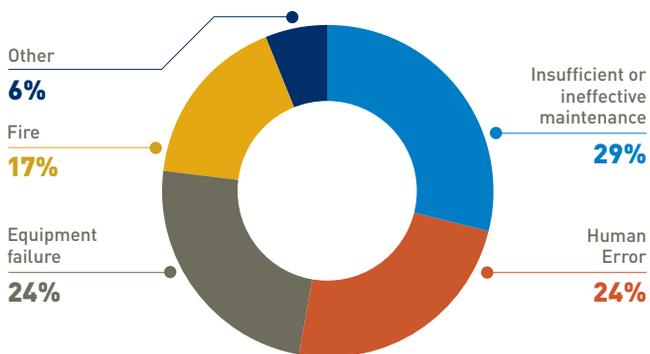
The main causes of propulsion loss by the London P&I club members' ships and for which P&I investigation was required during the last five full P&I years are as follows:

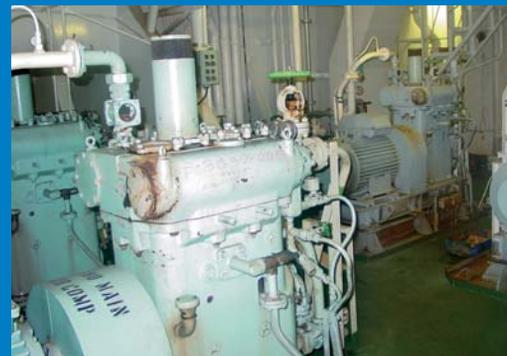
▶ Typical air compressors on a vessel

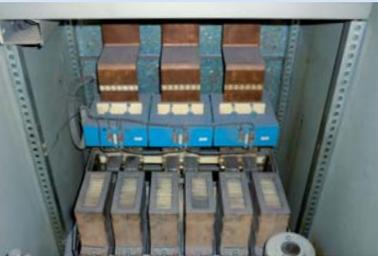
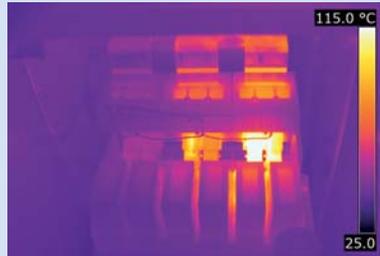
▲ Digital and thermal images of a switchboard breaker fault

- A regular thermographic survey of the switchboard should be carried out to monitor for loose connections or overheating equipment.
- The alarm printer, where fitted, should be maintained correctly, such that the printout is legible, as this is often a valuable source of information regarding the cause of the blackout.

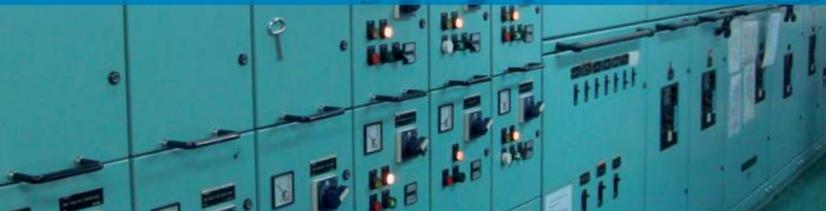
▲
Typical switchboard on a modern vessel

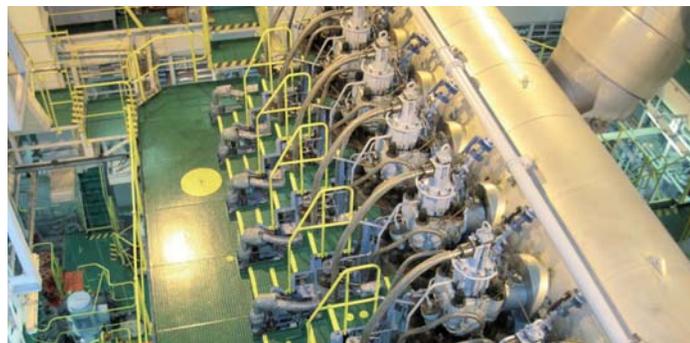
▼
Top platform of a large slow speed marine engine
