Smoke and mirrors

Grain cargo problems in Saudi Arabia

In the pipeline

Block stow reminder

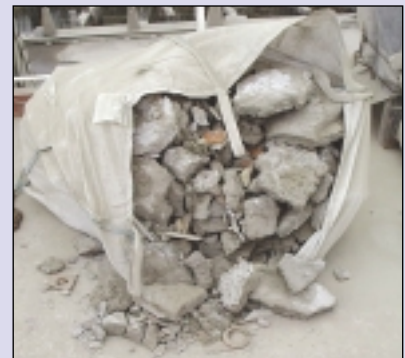
In another similar case, two holes in a sounding pipe allowed ballast water into a cargo space. Unfortunately, the hold contained

bulk cement, hence the relatively modest amount of water contamination led to a significant claim, for both cargo damage and extra discharging costs.

These cases are reminders that failure to pay due attention to the integrity of pipework can lead to expensive claims.

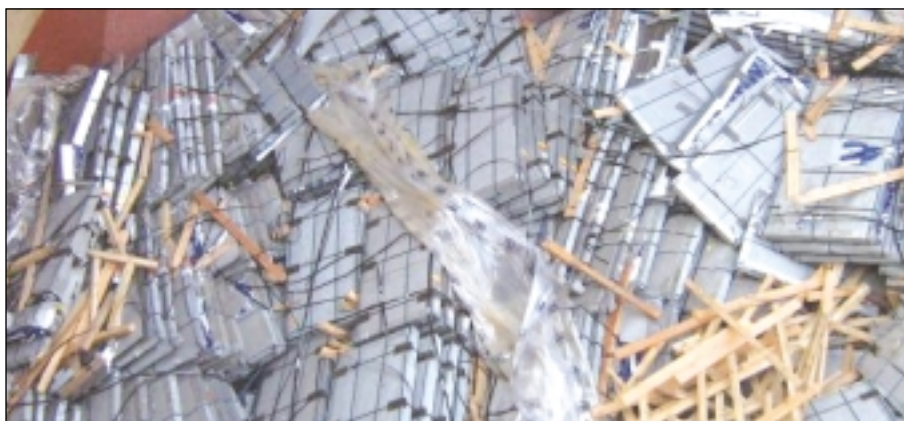
The Club's investigation of a recent cargo damage claim suggests that the shippers and charterers had tried to construct a variation of the California Block Stow, for part of a cargo of mixed steel products being carried from South America to Europe.

In this case, the cargo concerned was wrapped bundles of hot rolled steel plates and, rather than leaving the block stow free-standing, the shippers/charterers had attempted to support the cargo by means of wooden buttressing. However, when the ship hit heavy weather on passage, the wooden supports were unable to prevent the cargo shifting and, in one of the affected holds, the stow collapsed entirely.

Cases such as this illustrate the importance of special care in the face of plans involving the use of block stows. Members in any doubt should seek technical guidance and are welcome to contact stoploss@a-billbrough.com for assistance in identifying suitable experts.

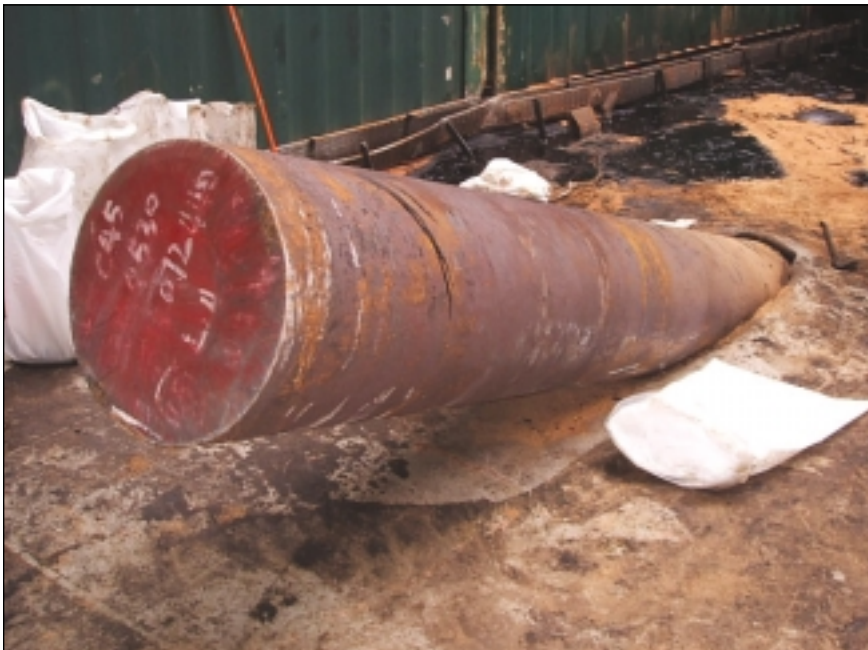
During a recent passage of a member's ship, a large steel billet broke free from the inadequate lashing within a container stowed under deck. The billet first burst through the side of the box and then fell into the empty adjacent bay, penetrating a bunker tank as it landed. The image above illustrates the risks and dangers to both ship and personnel that negligent shippers can create.
