The London P&I Club

# STOP Loss

MARCH 2017 | ISSUE 68

## Appointing a Marine Warranty Surveyor when loading deck cargo

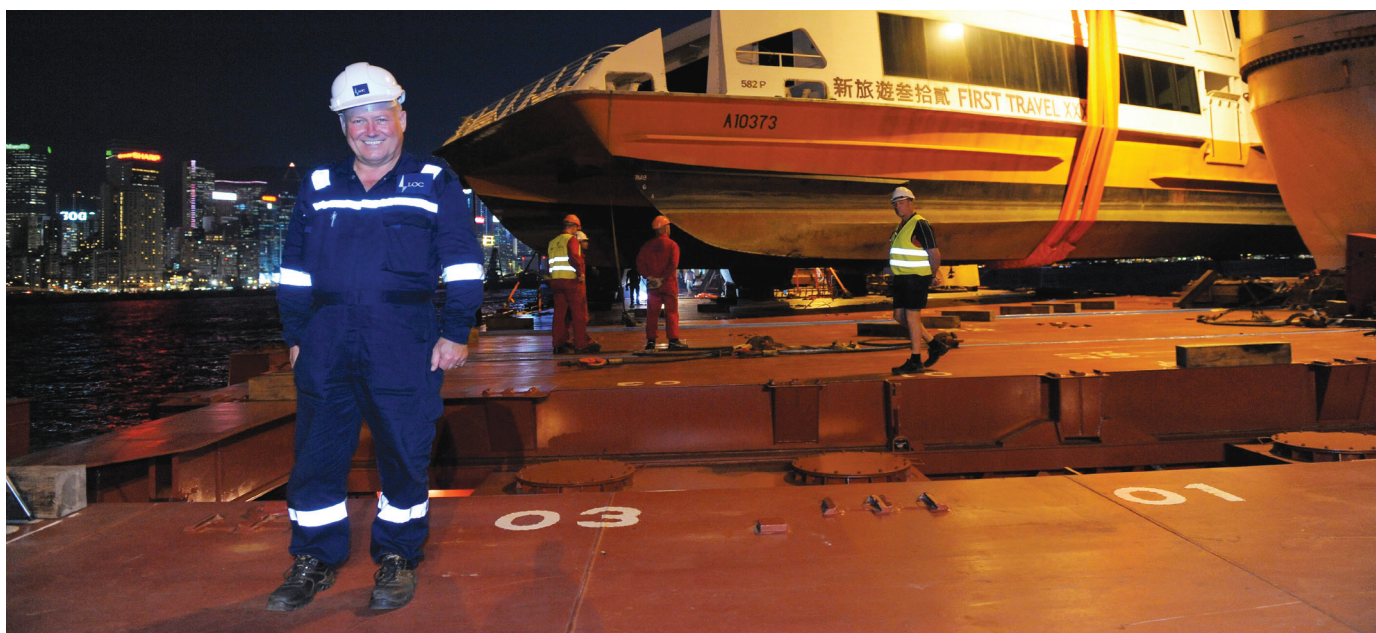
The author during the Marine Warranty Survey of local ferries being loaded on deck
